MINE SUBSIDENCE – HISTORY OF BORD & PILLAR MINING DAMAGE

Below are 80 examples at 20 Bord & Pillar mines refuting claims of ‘No evidence’ and ‘Negligible impacts’.

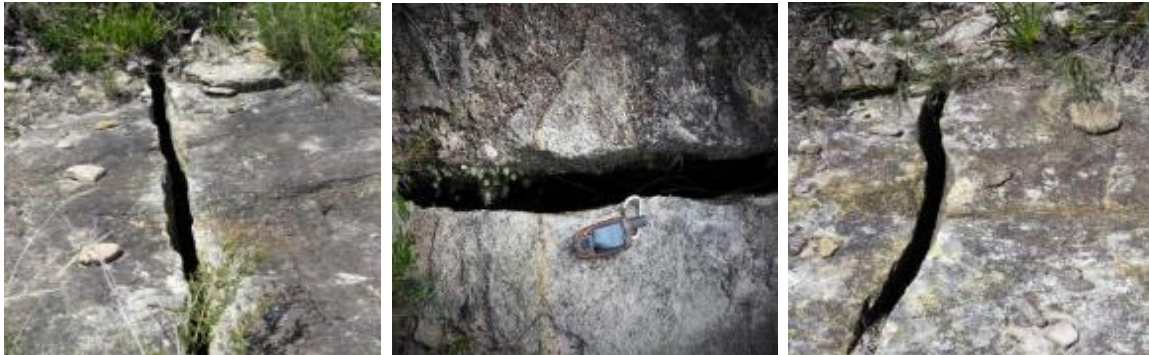
A Bord & Pillar mine in the Katoomba Seam originally opened as Hartley Vale No. 4 Colliery in 1956, Grose Valley Colliery from 1960 – 1987, and Canyon Colliery from 1990 - 1997. Subsidence cracks above the mine on Kamarah and Jungaburra Ridge allow vertical flow of surface and groundwater into mine workings, where it is contaminated with salts and heavy metals before discharge via a mine adit into Dalpura Creek and Grose River within the Blue Mountains Heritage Area (GBMWH).

Photo 1, 2, 3: Mine subsidence cracks on Kamarah Ridge and Jungaburra Ridge above Canyon Colliery – 10 February 2015

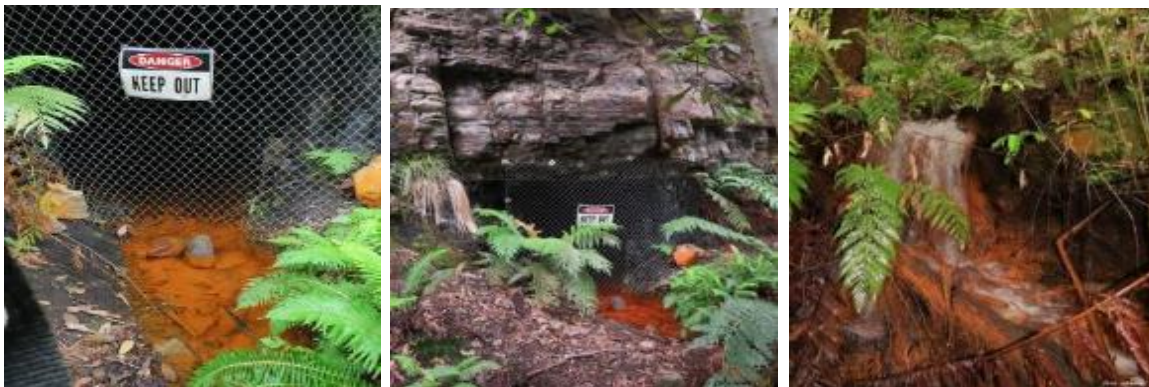
Zinc & nickel levels are up to 500 times above guideline limits, toxic to macroinvertebrates relied on by all aquatic life. Wright, I. and Burgin, S. (2009), 'Comparison of sewage and coal-mine wastes on stream macroinvertebrates within an otherwise clean upland catchment, Southeastern Australia', *Journal of Water, Air and Soil Pollution*, vol 204, no 40634, pp 227 – 241. www.smh.com.au/environment/sustainability/disused-mine-leak-is-killing-life-in-river-20080504-2atg.html

Photo 4, 5, 6: Contaminated mine water discharge from Canyon Colliery into Dalpura Creek and GBMWH – 5 May 2015

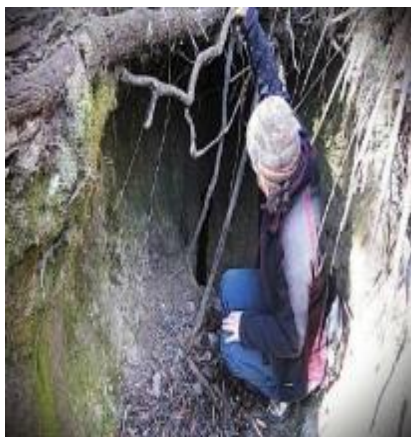
First recorded July 2010, last sighted April 2024. Large sinkhole 200m long x 10m wide x 2m deep with a 150-250mm wide subsidence crack at its eastern end. The crack runs east-west across a northerly flowing tributary of Bungleboori Creek. All surface water that once flowed down this creek now flows down that crack, and the creek and THPSS downstream are totally dry. Groundcover vegetation has not recovered in 14 years of observation, with many bare and denuded areas.

Photo1: Site 1 Crack in sinkhole - July 2010

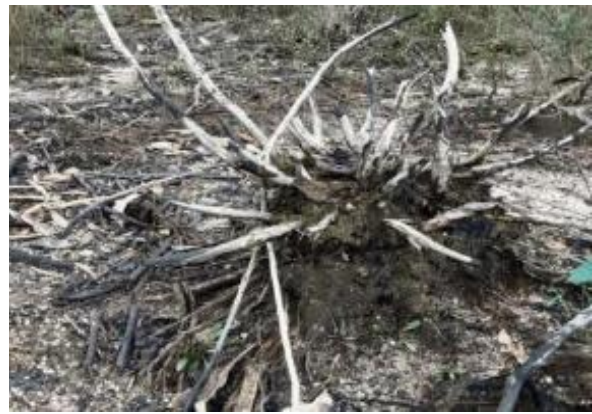
Photo 12: Remnant Leptospermum stump in dead THPSS

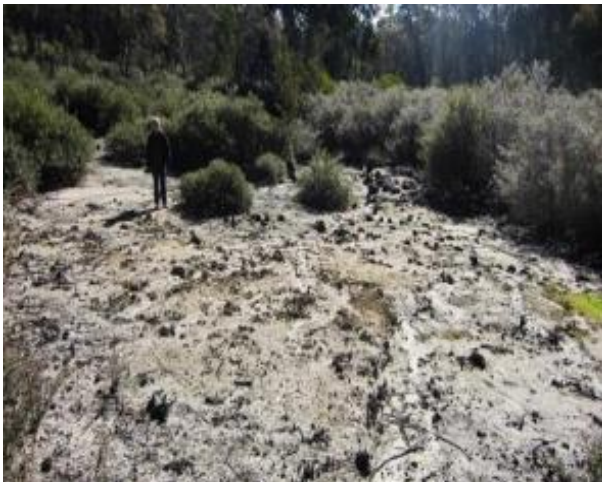
First recorded July 2010, last visit June 2024. At least 400m of this THPSS is dead (entire length not walked), and dead Hanging Swamps occur along the verges. Severe erosion downstream has liberated 1000s of tonnes of silt which will end up in Bungleboori Creek and ultimately the GBMWHA.

Photo 13: Site 4 Dead/Damaged THPSS - July 2010

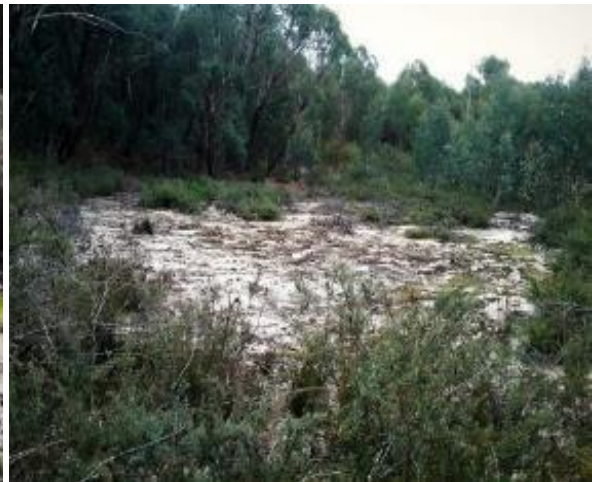
Photo 14: Dead/Damaged THPSS – June 2024

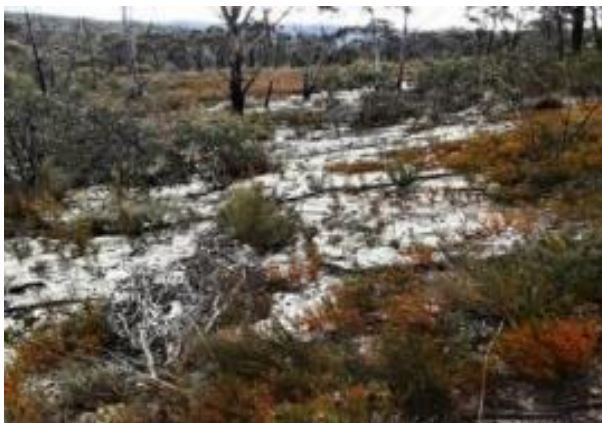
First recorded July 2010, last visit April 2024. Damaged THPSS Hanging Swamp extending 240m or more along a slope below a ridge. Occasional bare patches further downhill towards swamp in creek.

Photo 15: Site 5 Damaged Hanging Swamp - June 2024

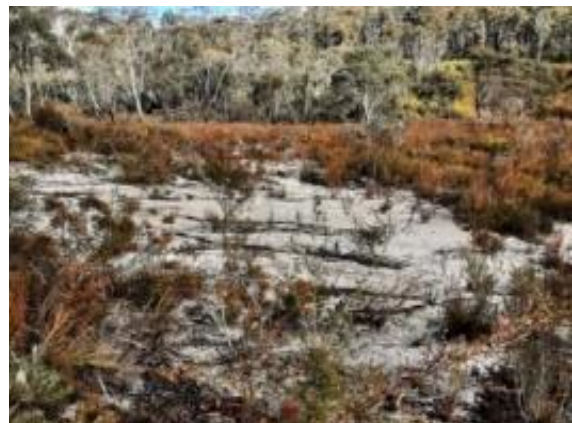
Photo 16: Site 5 Damaged Hanging Swamp – June 2024

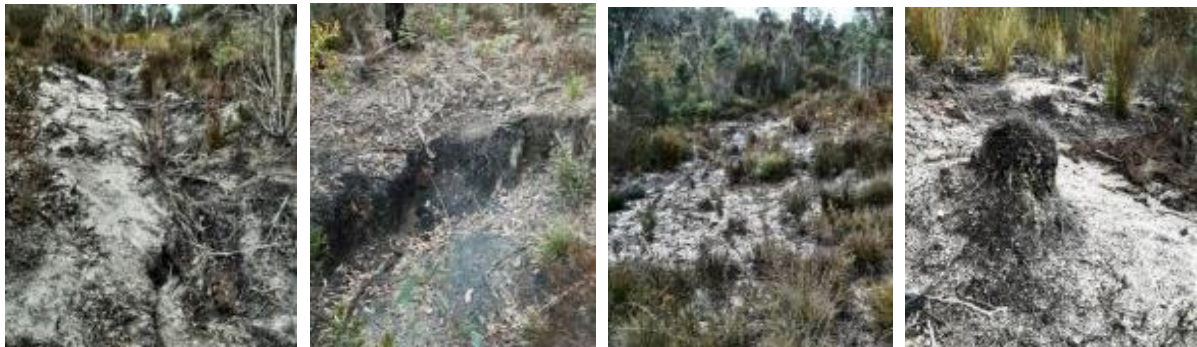
First recorded October 2008, last visit June 2024. Dead Hanging Swamp, more damage upstream. Little has regrown in 16 years as the creek and swamp are totally dry. Severe erosion & siltation.

Photo 19-22: Site 7 Dead THPSS Hanging Swamp with more damage upstream – after 16 years little has regrown – June 2024

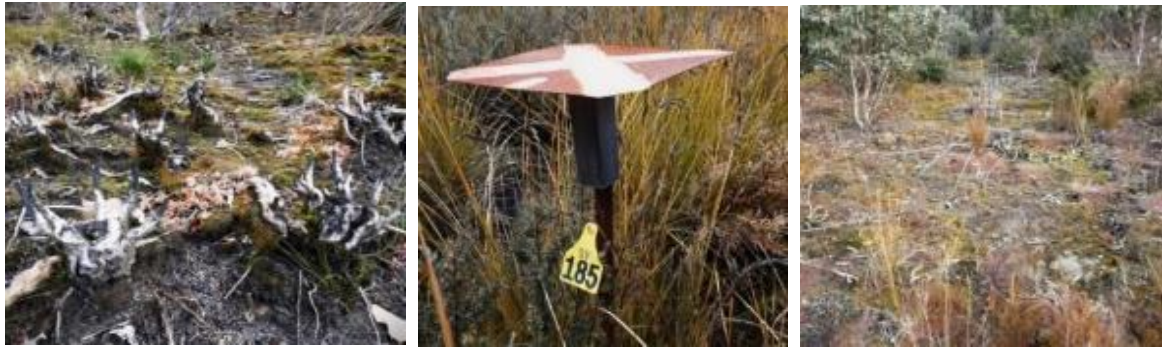
Upper Paddys Ck Swamp exhibited all the hallmarks of a THPSS which had been undermined. Att 17 Clarence 2023 Groundwater Monitoring Results states ‘PSE2 exceeded the trigger level in 2023. In August 2022 active mining of Panel 909 occurred approx 200m east of PSE1, and while PSE2 was undermined no mining impacts were observed. During the reporting period, active mining of Panel 919 was approx 50m east of PSE1 and 800 to 850 m north-east of PSE2. No impacts were observed’.

Clearly Upper Paddys Creek Swamp was drained by Panel 909, and subsequently damaged by the December 2019 fire. This damage is only a short distance from vegetation monitoring points SV184 & 185 and Centennial must have been fully aware of it. Why wasn't this THPSS damage reported?

Photo 23, 24, 25: Site 8 – Upper Paddys Creek Swamp, Panel 909. Damaged THPSS, SV185, & limited recovery after fire

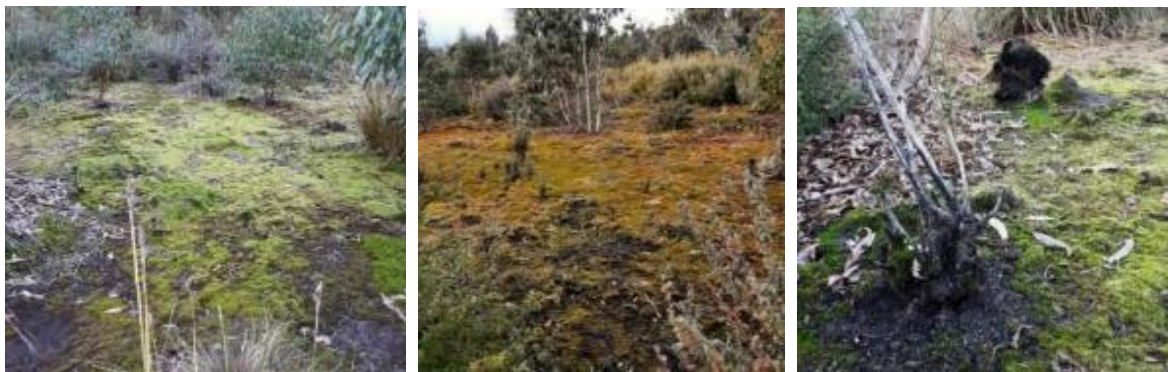
Photos 26, 27, 28: Site 8 - Upper Paddys Creek Swamp, Panel 909. Moss but little else regenerating 4.6 years after fire.

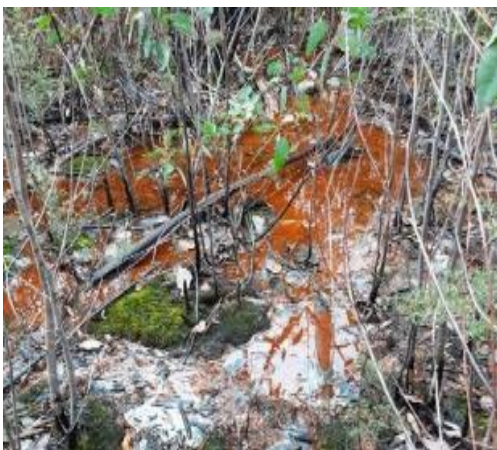
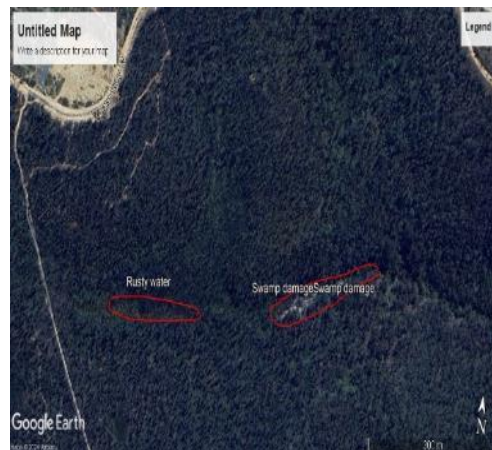
Vegetation along this creekline was damaged by early Clarence Colliery mining (Longwall 1). What was once a swamp is slowly reverting to Eucalypts and Acacia, however little groundcover vegetation has regenerated to stabilize the sand and peat to control erosion and siltation.

In addition the water has a distinct rusty-red discoloration not sighted in nearby creeks. This is not unlike Lambs Creek in the Angus Place 300 Area where subsidence cracks allow vertical groundwater flow from upper aquifers into incised valleys, picking up oxidizing sulphuric minerals along the way.

All coal seams slope downhill in a north-east direction, Panel 414/Longwall 4 are the lowest Clarence mine workings, and it is feasible that minewater seepage contaminated with Iron, Manganese, Nickel etc is resulting in metal pollution of Bungleboori Creek which flows into the GBMWHA – a MNES.

Photo 32 & 33: Site 11- Rusty-red discoloured water & swamp damage Longwall 1 – June 2024

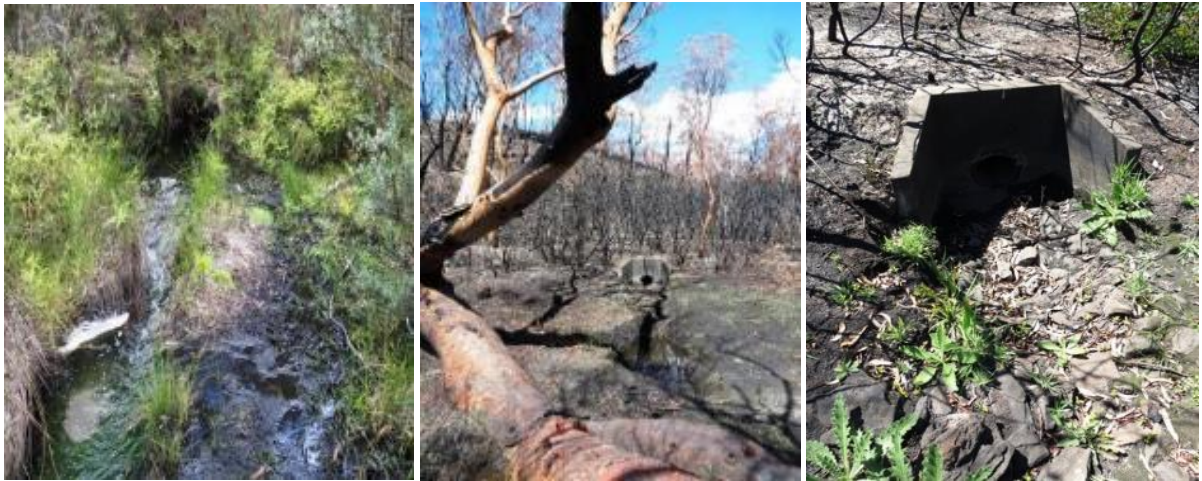
Farmers Creek South Swamp was drained by Clarence Colliery Panel 707 in 2012 and subsequently severely damaged by the State Mine Fire in October 2013. Previous damage had occurred due to the Clarence Water Transfer Scheme (CWTS) discharge point (33.456013, 150.222956).

Photos 34,35,36: Site 12 - CWTS Discharge Point into Farmers Creek Swamp on 31 January 2010, and after the 2013 fire.

The Sydney Catchment Audit 2010 included Recommendation 9: *Lithgow City Council & Centennial Coal should ensure that water transfers from the Clarence Water Transfer Scheme are piped around, rather than flow through, Farmers Creek Swamp.* The Federal Government provided \$4 million in funding.

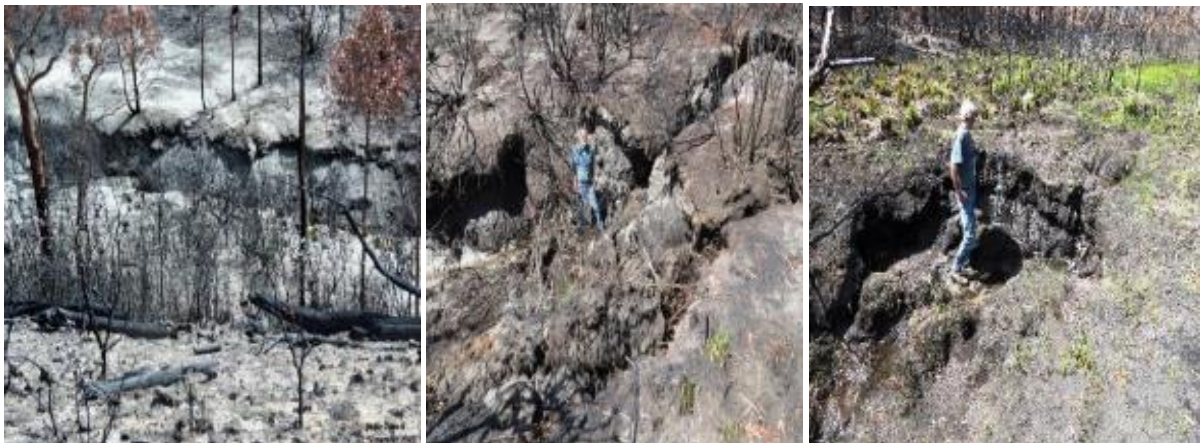
Photos 40, 41, 42: Site 12 – Erosion, scouring, slumping after undermining by Panel 707 and State Mine Fire – 24 November 2013

That work was completed in August 2013, however just 8 weeks later was partly destroyed by the October 2013 State Mine Fire which melted poly pipes that had been laid above-ground. Meanwhile damage due to undermining of this swamp by Panel 707 slipped under the radar.

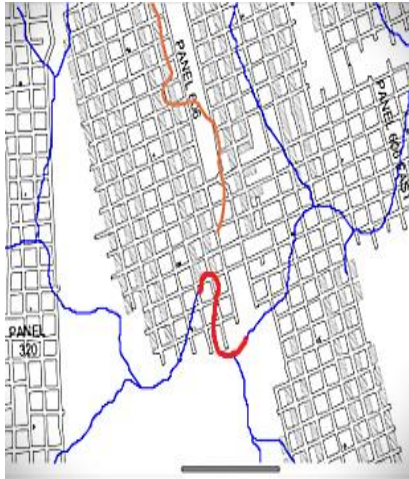
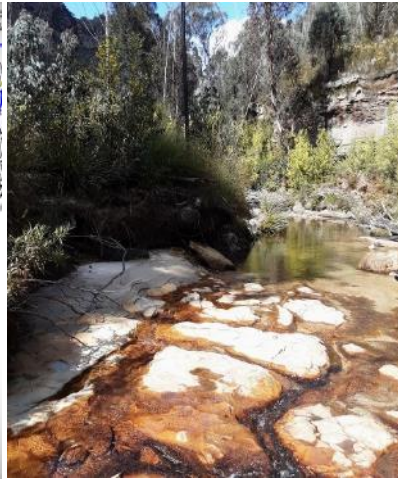
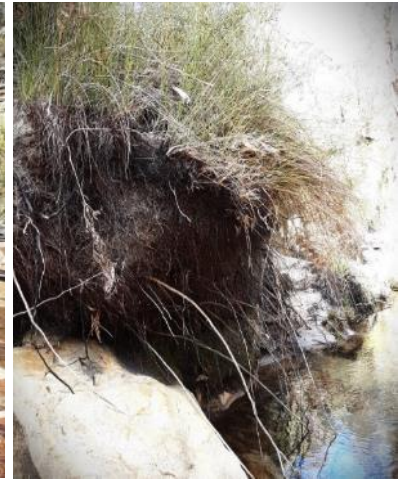
Fig 3: Panel 606 creek damage(Red) Photo 45 & 46: Bungleboori Ck under-cutting bank & forming new channel

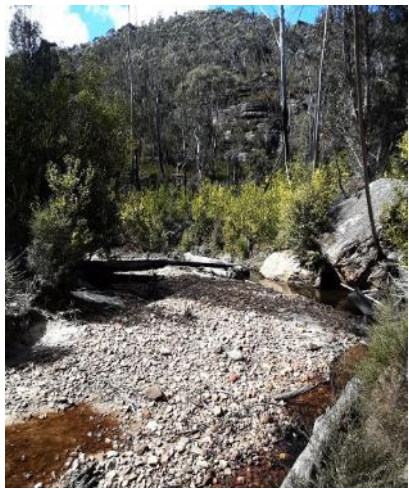
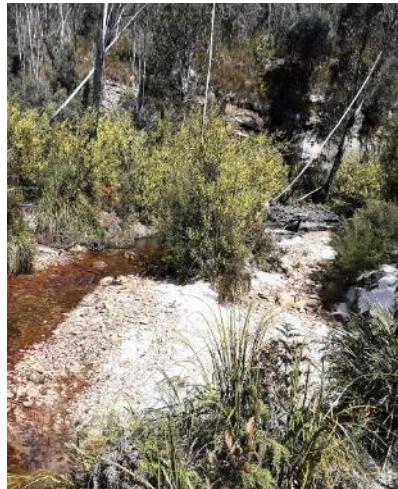
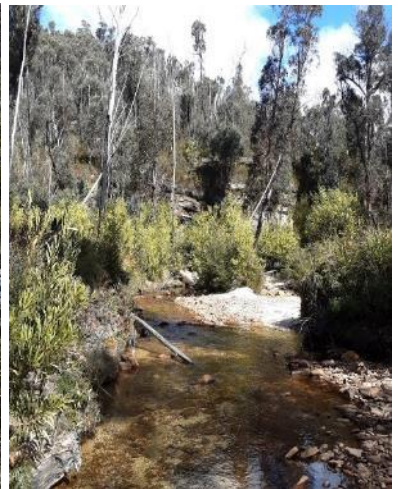
Photo 47, 48,49: Bungleboori Creek tilted by Panel 606, abandoning old channel, and forming new channel

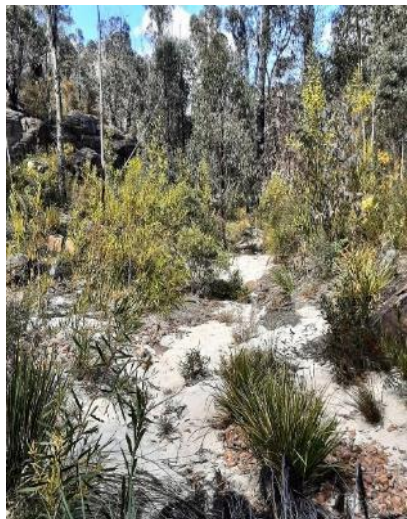
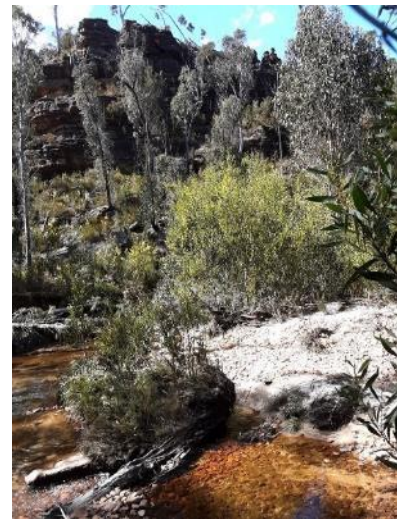
Photo 50 & 51: Bungleboori Creek tilted by Panel 606 & forming a new channel

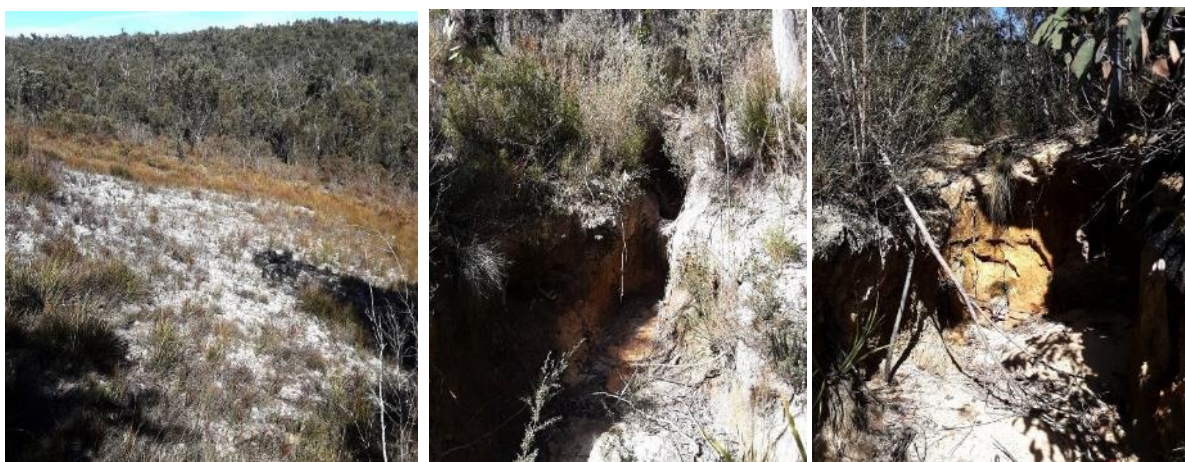
THPSS Hanging Swamps above Panel 308 have died, the entire length of the creek for about 1km to its junction with Bungleboori Creek has dried up, there are possible sinkholes, and severe erosion.

Photo 52-55: Site 14 - Dead hanging Swamps, dried up creek, possible sinkholes, severe erosion

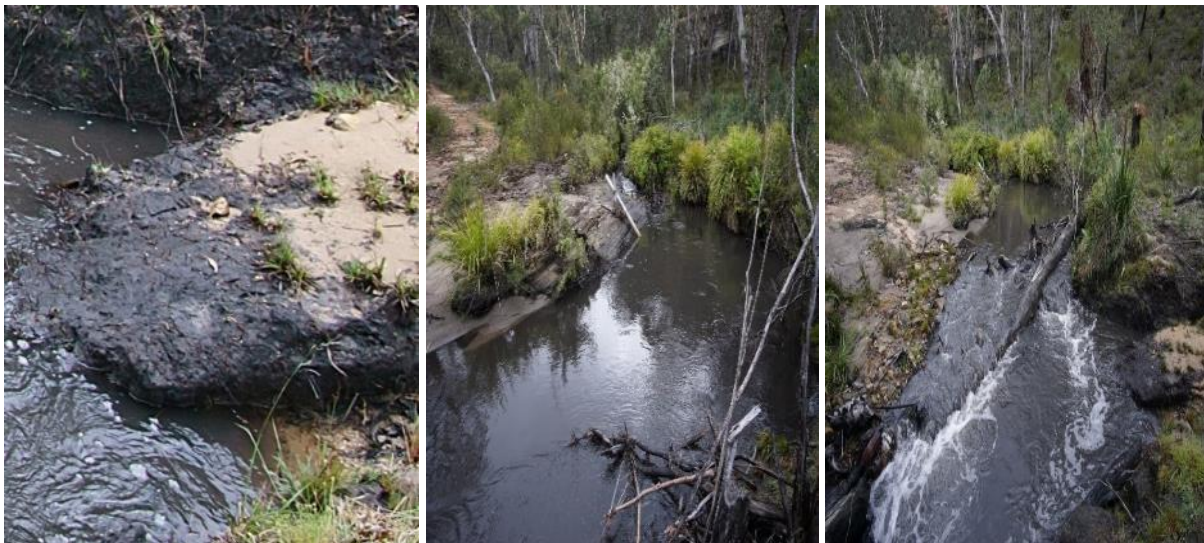
The Clarence Colliery coal-fines spill into the Wollangambe River on 22 December 2023 was reported by LEG, not by Centennial. This highlights an ongoing issue with Centennial mines in the Lithgow area - failure to report incidents of environmental harm.

Photos 59-61: Clarence Colliery coal-fines spill into Wollangambe River – 22 December 2023

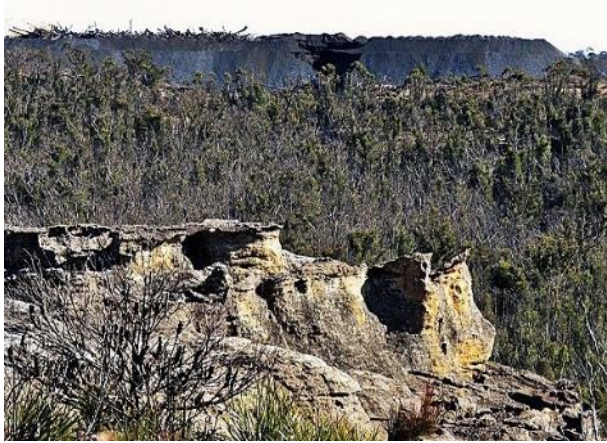
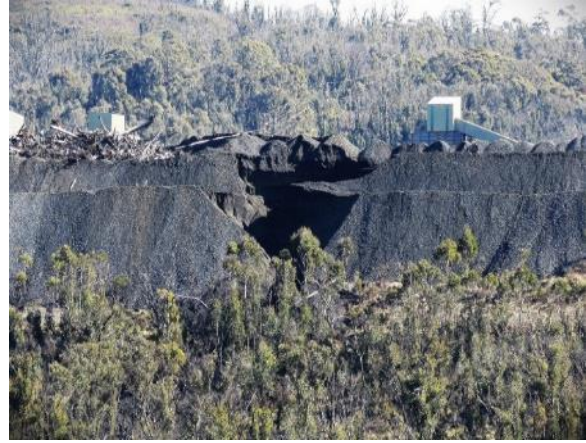
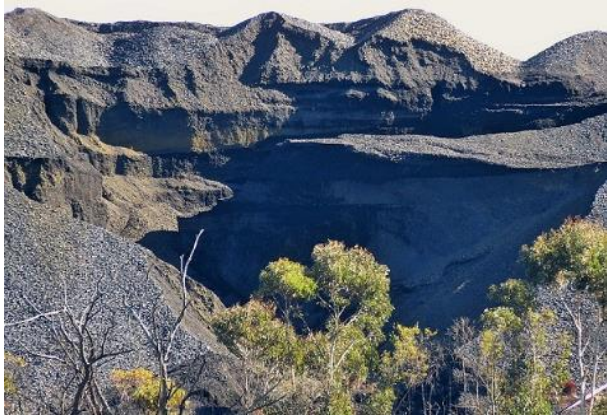
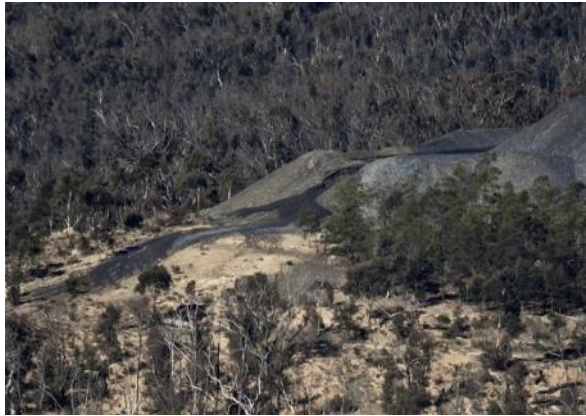
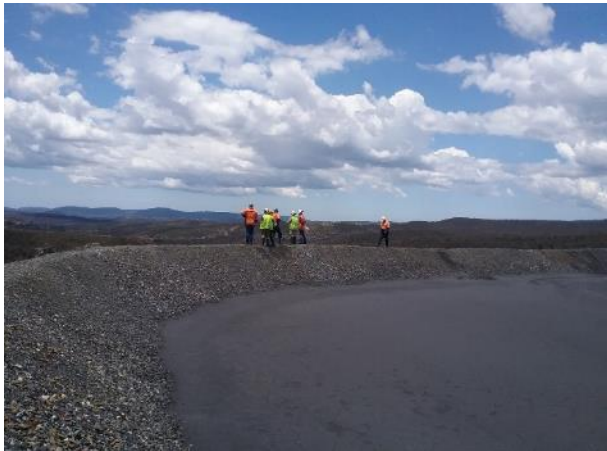
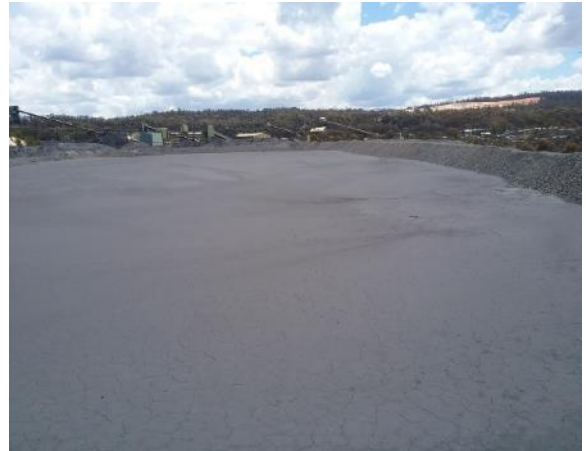
On 2 July 2015 part of the eastern wall of Reject Emplacement Area (REA) 3 failed, resulting in the release of coarse reject and 2,330 tonnes of coal fines into the Wollangambe River & GBMWHA. The Land & Environment Court convicted Clarence Colliery P/L of two offences and imposed financial penalties totalling \$1,050,000 plus \$106,010 in investigation and legal costs - the single largest fine following prosecution by the EPA.

REA3 was approved by Lithgow City Council in 1993. The collapse of a dam built out of coarse reject material was clearly foreseeable. The likelihood of anything approved by Lithgow Council failing was clearly foreseeable. The fact REA3 had been full since 2011 and overtopping could occur was clearly foreseeable. Lithgow Council's development approvals 174/93 and IRM.GE.76 are in Perpetuity.

Photo 62-69: Clarence Colliery Reject Emplacement Area ("REA") 3 – collapsed on 2 July 2015

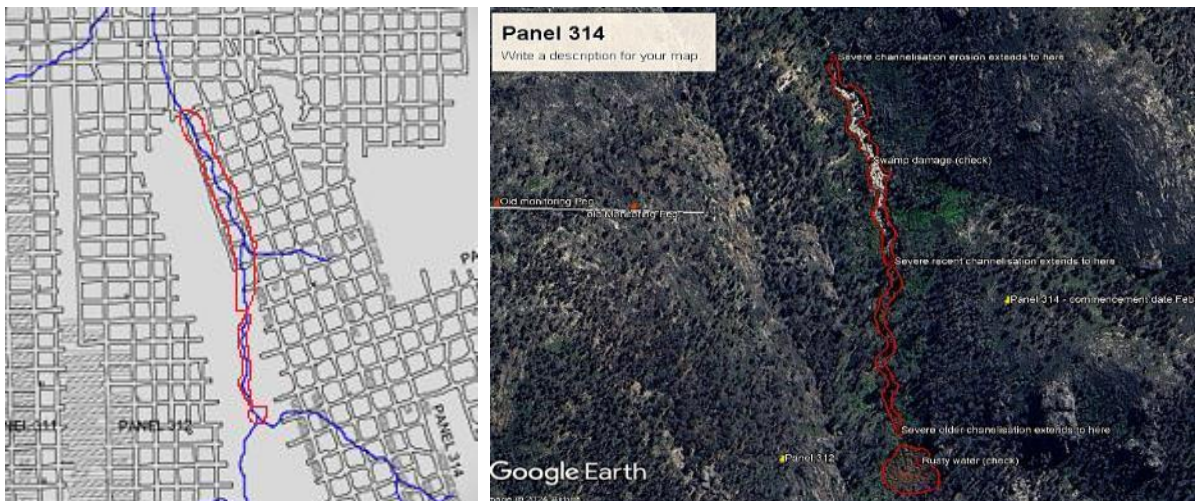
This is the most severe channelisation and erosion LEG has seen on Newnes Plateau. The most recent damage is clearly visible on Google Earth, extending for 200m and up to 20m wide x 4m deep. It corresponds almost exactly to where Panel 314 passed underneath this creek. Remnant *Olearia quercifolia* and other swamp species suggest THPSS or Hanging Swamps once occurred pre-mining.

Older channelisation and erosion extends a further 150m upstream, near to a patch of rusty-red water visible on GoogleEarth, possibly minewater seepage, which disappears underground. Old pegs along a subsidence monitoring line occur on the ridge to the west. LEG believes the initial damage was caused by early 300 Panels (Wongawilli Full Extraction), and reactivated by Panel 314 post 2010.

Photo: 76 & 77 Clarence Colliery Panel 314 – Severe channelisation, erosion & dried-up creek in former THPSS

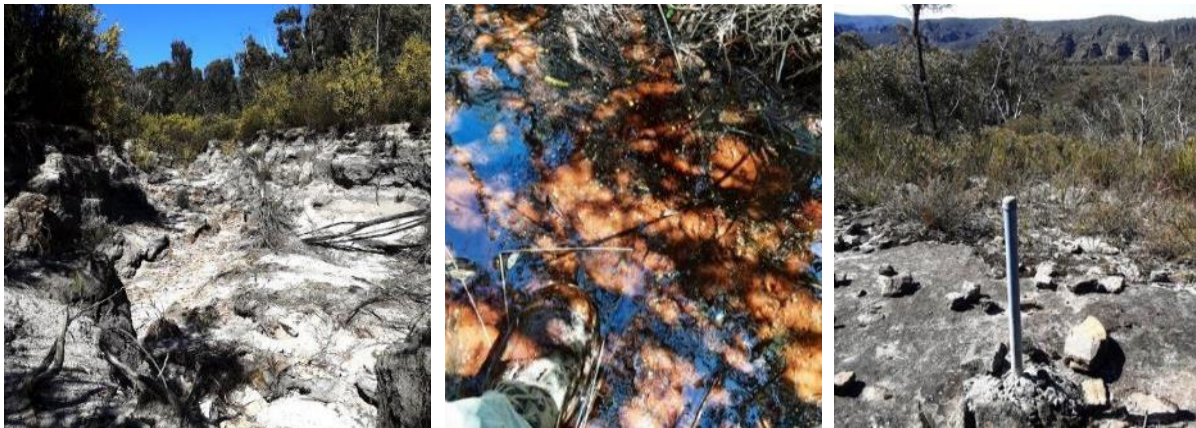
Photo 80-82: Panel 314 – Severe channelisation, erosion, rusty-red discoloured water, old mine subsidence peg

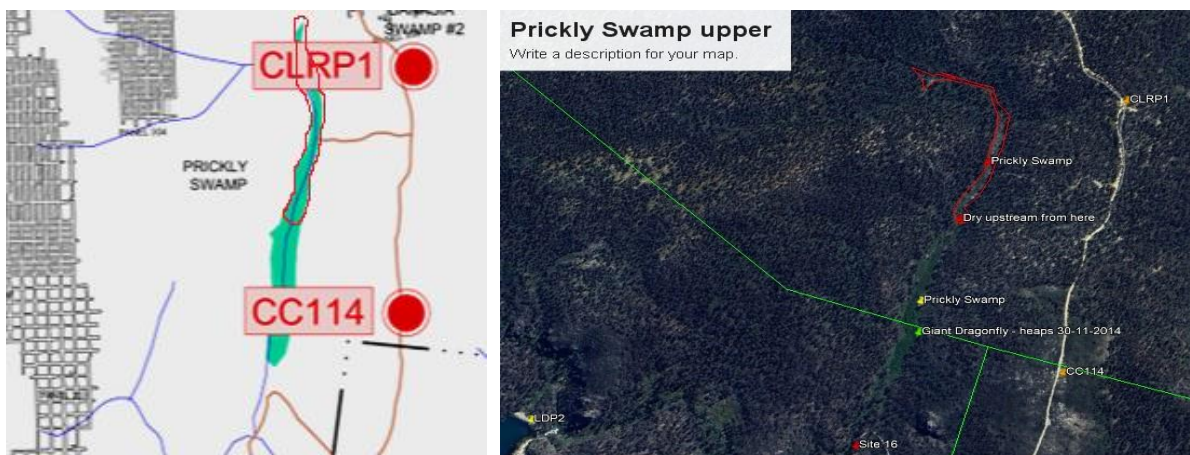
Prickly Swamp is mapped by Centennial as a Newnes Plateau Shrub Swamp (*Clarence Colliery Annual Environmental Monitoring Report (AEMR) 1 January 2023 to 31 December 2023, Appendix A*). The upper half of this swamp has dried out, and erosion is visible. The first sign of any surface water is at -33.450783, 150.258430. CLRP1 (Vibrating Wire Piezometer) reported “Data gaps exist due to logger issues”. CC114 (VWP) reported “A new logger was installed in October 2021 due to reliability issues.”

Photos 80-82: Maps of THPSS damage to upper Prickly Swamp

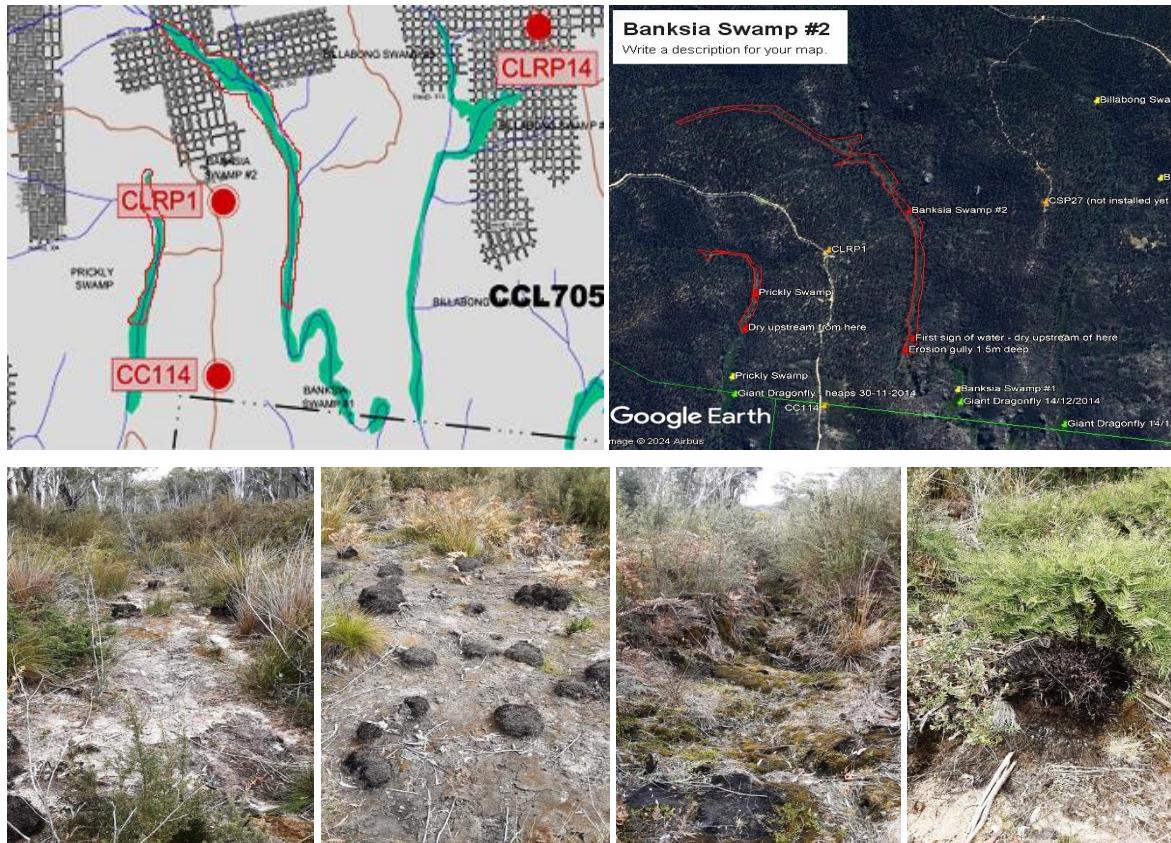
Banksia Swamp #2 is mapped by Centennial as a Newnes Plateau Shrub Swamp (*Clarence Colliery Annual Environmental Monitoring Report (AEMR) 1 January 2023 to 31 December 2023, Appendix A*). At least 1km of this swamp was dry at the time of visit. The first sign of any water was at -33.451538 150.263433, and that was 1.5m below the swamp surface in a deep erosion gully. The upper sections of this swamp were undermined by Panel 330 & 332. Mine dewatering may be a contributing factor. Erosion nick-points are forming (eg. -33.451538, 150.263433) and should be monitored/stabilised.

Photos 83-88: Site 22 – Banksia Swamp #2. Dry desiccated THPSS, erosion & nick points starting to occur.

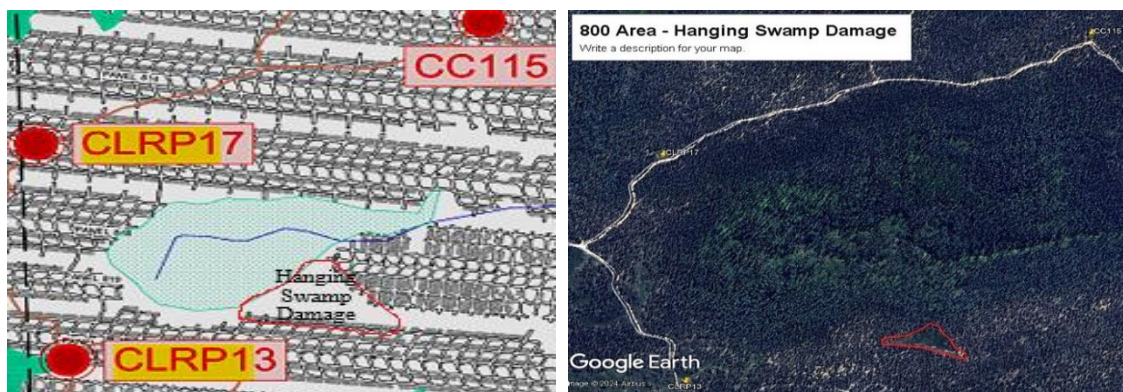
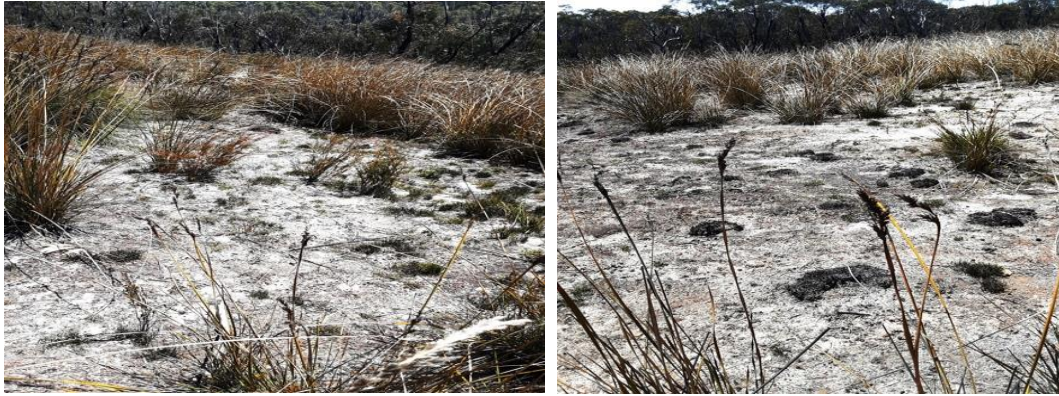
This small MU51 Hanging Swamp is desiccated and showing signs of mining damage. It is about 500m east of CLRP13 on the eastern edge of the diatreme which Panels 818A/820 had to avoid.

Photos 89-92: Site 23: Dead Hanging Swamp in 800 Area ("The Boot") about 500m east of CLRP13.

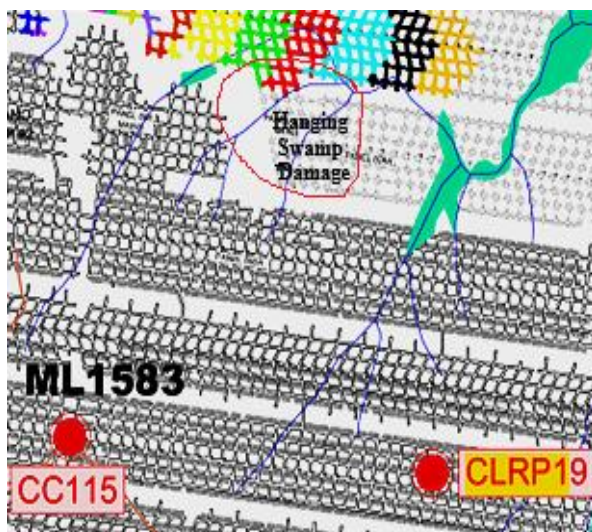
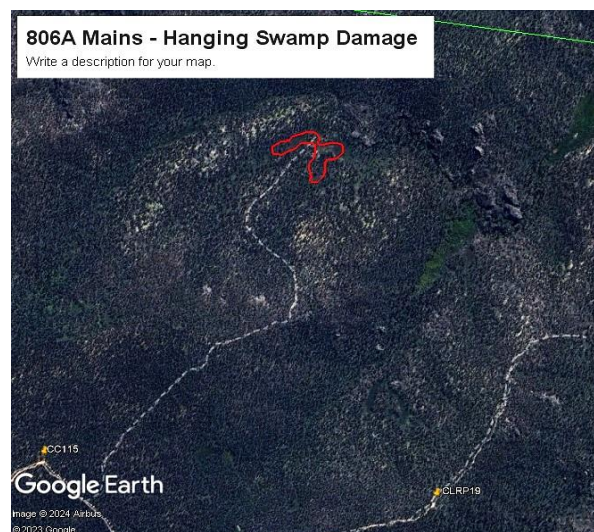
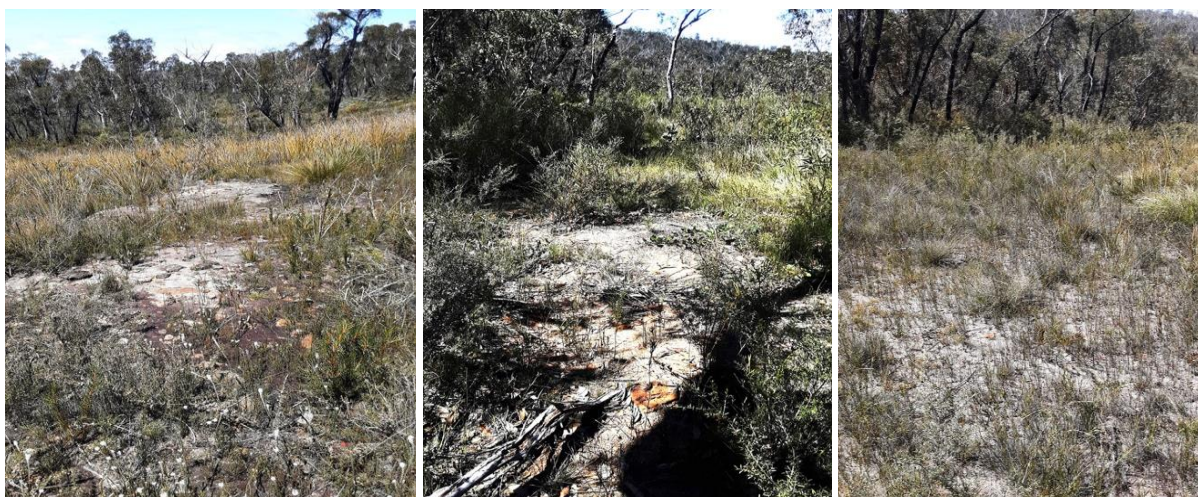
Several Hanging Swamps in this area are showing early signs of deterioration and the creek upstream is dry. Panel 806A is currently being mined. CLRP19 reported "Depressurisation response since August 2021 due to mining Panel 818A. Continued decreasing trend during reporting period." Panel 812 undermined CC115 and all piezos depressurised due to first workings in June 2013. "Further depressurisation was observed in May 2016 following pillar extraction. A depressurisation response in Piezos #1, #2 and #3 (below the MYC) was observed in August 2021 due to mining of Panel 818A. During the reporting period, active mining of Panel 804 and Panel 806A was within 1 km of CC115. Following initial depressurisation observed in 2021, Piezos #1, #2 and #3 continue to show a decreasing trend".

Photos 93-97: Site 24: Damaged Hanging Swamps Panel 806A Mains, 800 Area ("The Boot").

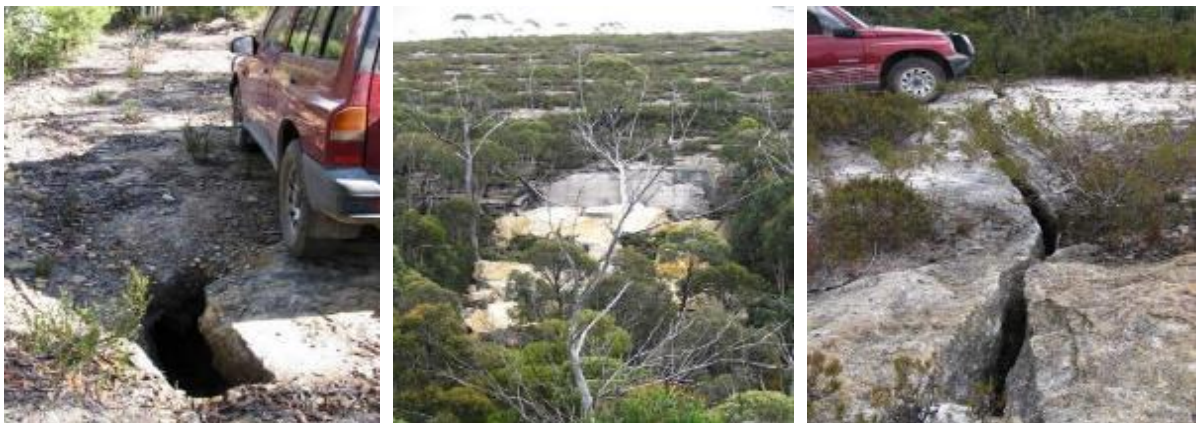
Cobar Park Colliery was a Bord & Pillar mine in the Lithgow Coal Seam. Numerous incidents saw Farmers Creek disappear into the mine void; 2.7km of the creek having to be concrete lined; houses lost; a drowning; subsidence cracks; a cliff fall; and culminating in the closure of the State Mine in 1964.

Photos: Cliff fall and subsidence cracks on Newnes Plateau above Cobar Park Colliery bord & pillar workings – March 2009

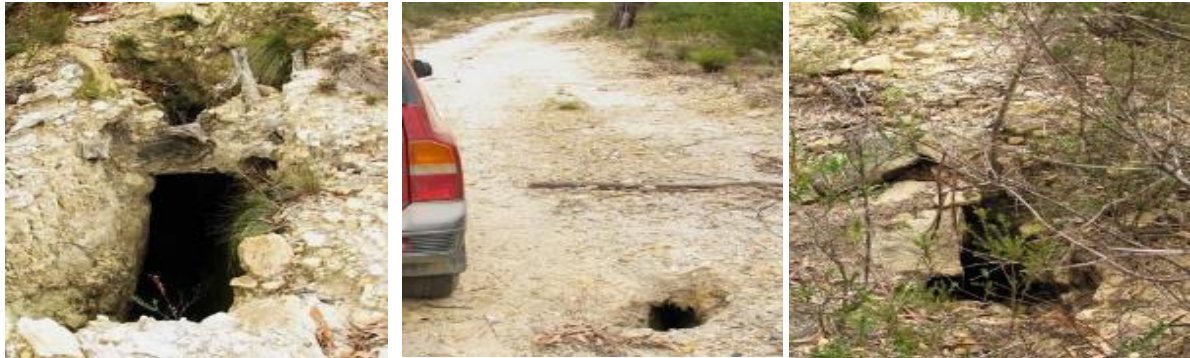
Photos: Subsidence cracks on Newnes Plateau above Cobar Park Colliery bord & pillar workings – March 2009

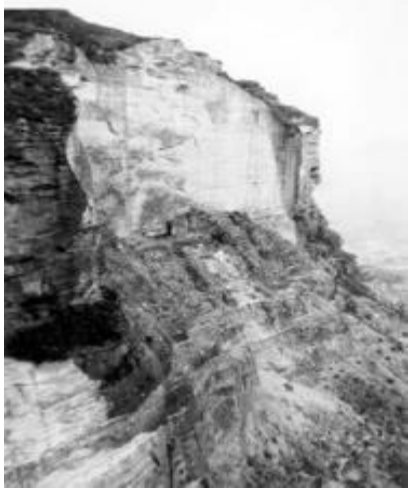
Partial extraction mining in the Lithgow Valley Colliery & Hassans Walls Colliery occurred beneath Hassans Walls Reserve between 1938 and 1974. LEG has recorded thirteen (13) cliff falls, the most recent of which occurred in June 2015, March 2015, and August 2007. Previously two cliff falls occurred before 1969, two (2) in 1970 or 1971, and at least nine (9) more since mine closure. Cliffs continue to fall 50 years after mining ceased. Surface cracking also occurred, with large fissures up to 0.5m wide. Monitoring continued long after mining ceased, and showed that some cracks were continuing to widen.

Photo 1: Cliff Fall - Hassans Walls 1960s

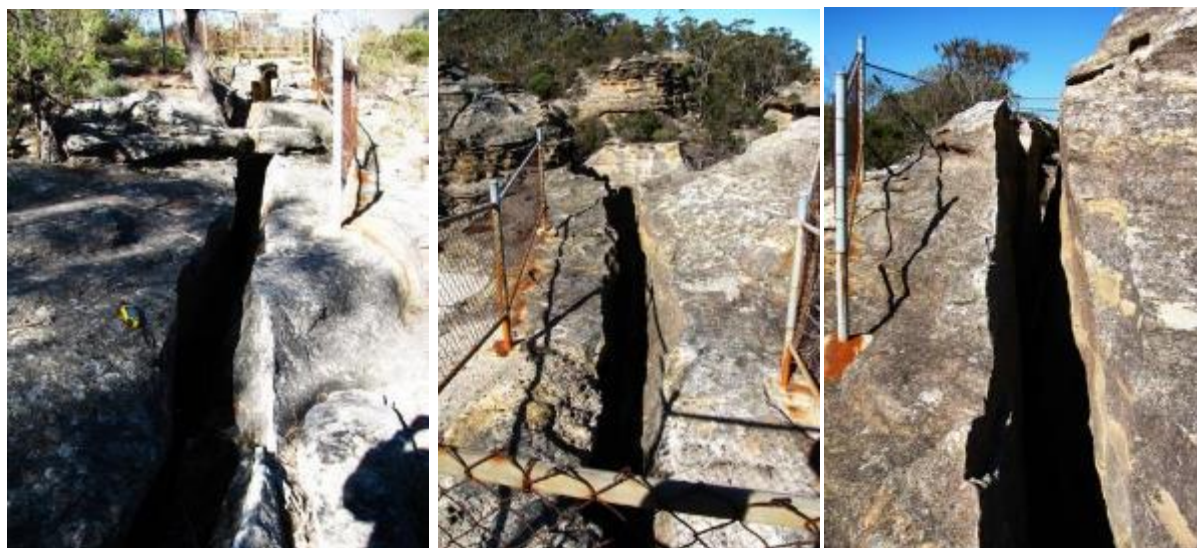
Photos 13, 14, 15 - Mine subsidence cracks – Hassans Walls Reserve – May 2009

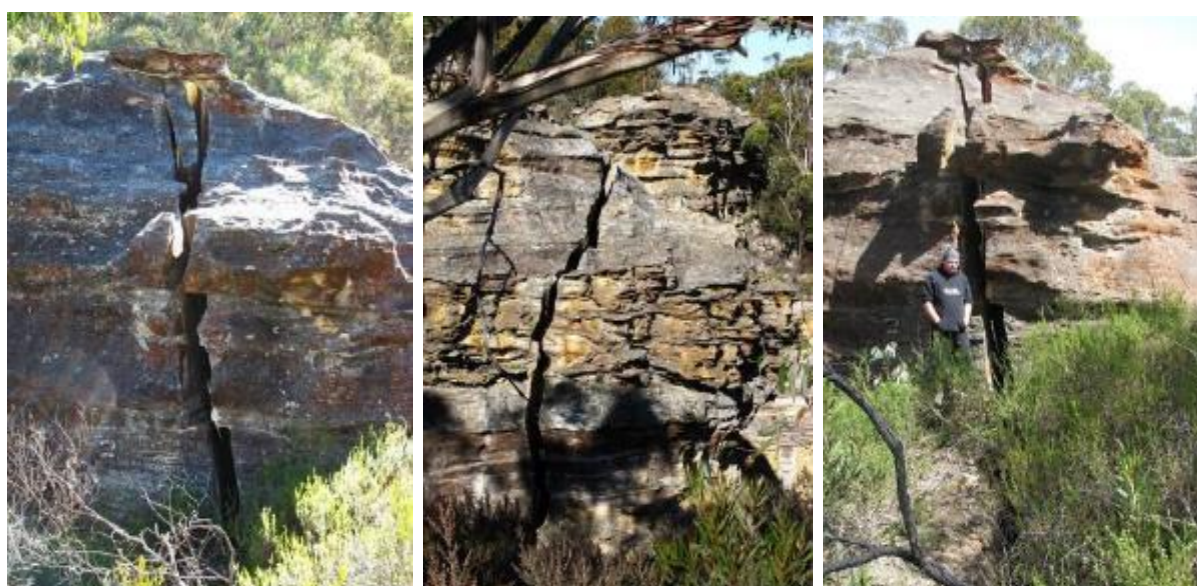
Photos 16, 17, 18 - Mine subsidence cracks – Hassans Walls Reserve – May 2009

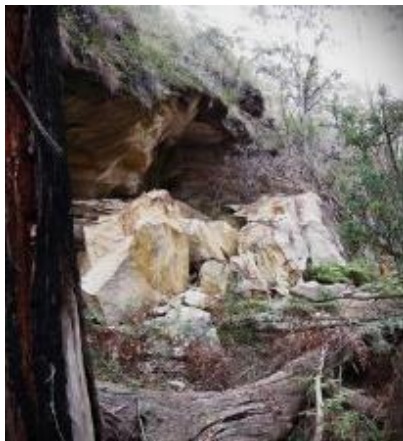
Photo: Cliff fall Invincible 14 March 2013

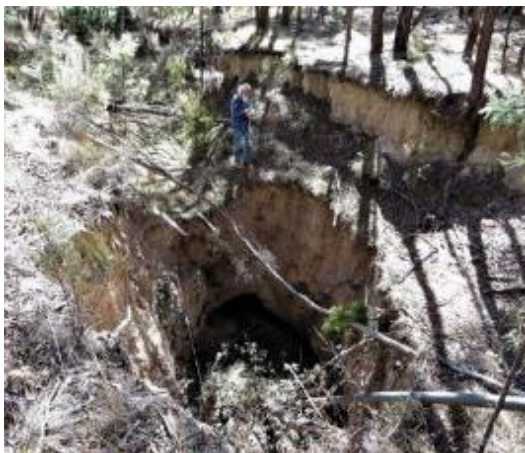
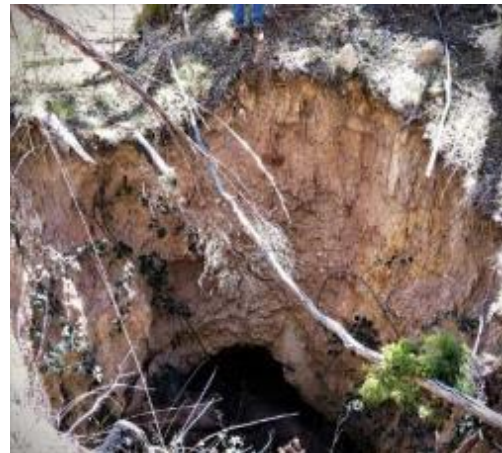
Photos: Invincible Colliery – Creeks disappearing down subsidence cracks into mine void – 19 August 2017

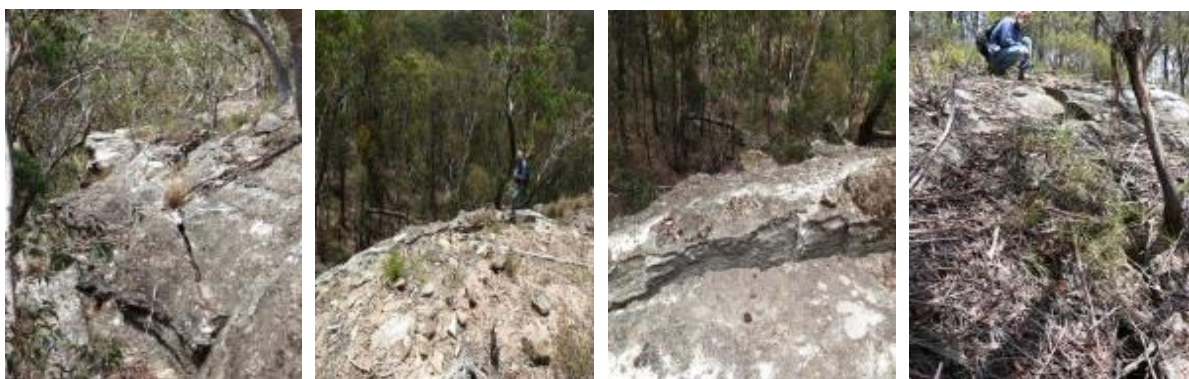
Photos: Subsidence cracks – Invincible Colliery Bord & Pillar/partial extraction areas

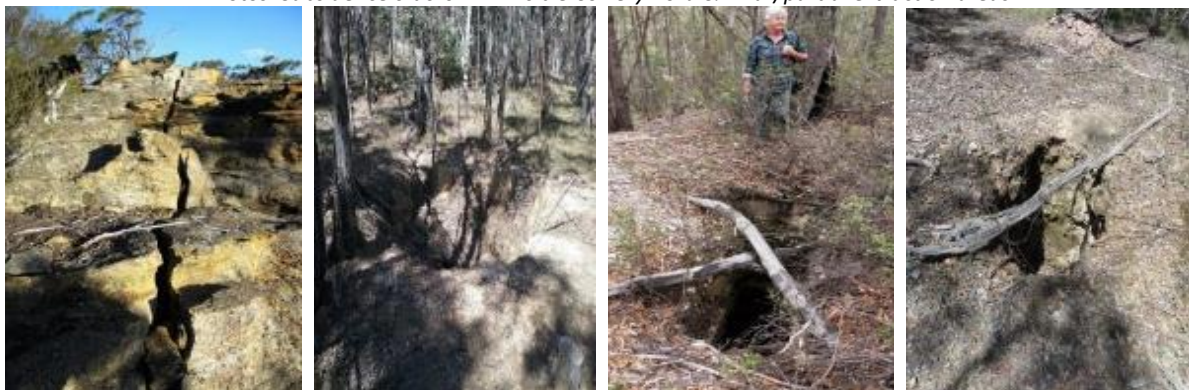
Photos: Invincible Colliery mine subsidence damage to pagodas, sinkholes, and open mineshafts

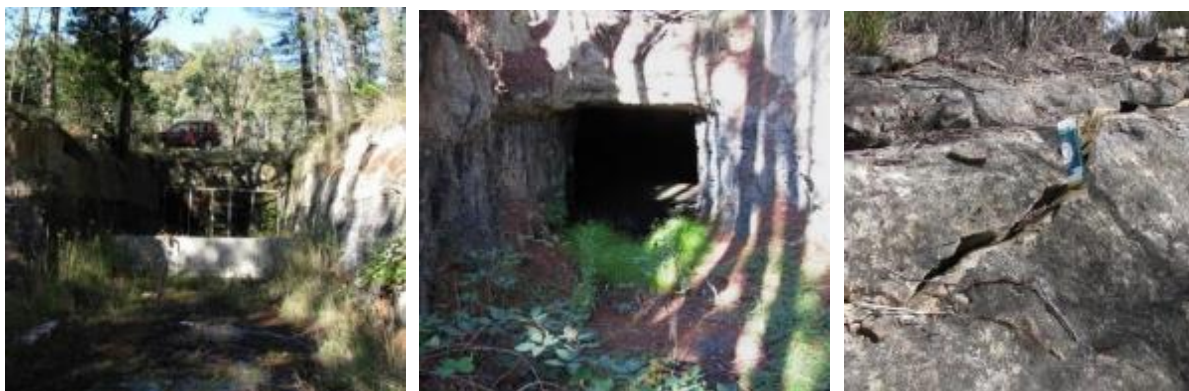
Ivanhoe Colliery was a Bord & Pillar mine. Subsidence cracks occur throughout. An EPA compliance audit of POEO Licence 631 on 25 June 2002 recorded “water containing visible oil and grease being discharged into underground workings of the mine.” Two mine drifts (one about 400 metres long to the Mudgee Railway Line) conduct rusty water towards the old Irondale Mine, Pipers Flat Creek, and hence Coxs River.

Photos: Ivanhoe Colliery – old mine drifts allow water to flow SW under Boulder Rd to Pipers Flat Creek & Coxs River – March 2010
