MINE SUBSIDENCE – HISTORY OF BORD & PILLAR MINING DAMAGE

Below are 80 examples at 20 Bord & Pillar mines refuting claims of ‘No evidence’ and ‘Negligible impacts’.

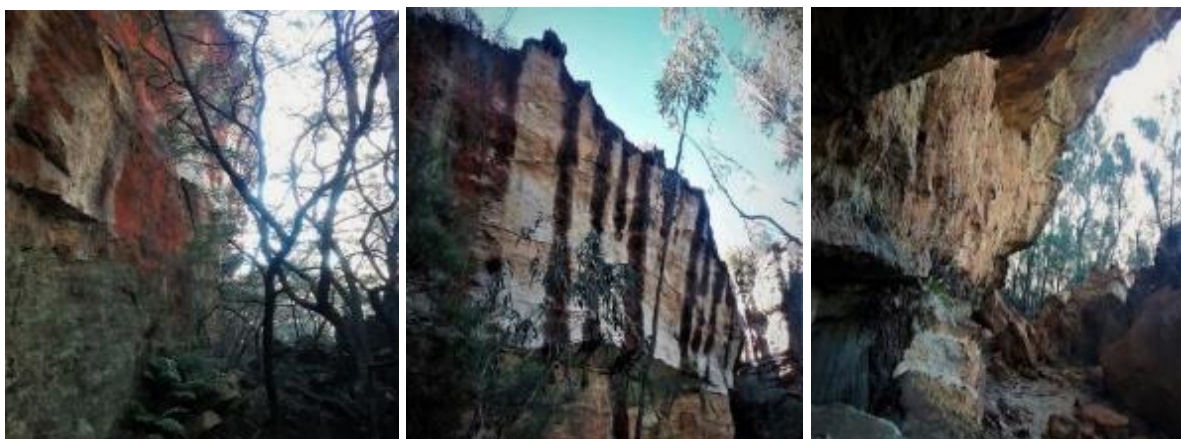
The State Mine was a Bord & Pillar mine operated by the NSW Government from 1922 to 1964. The workings were - Heading & main winning bords: 5 yards wide x 7 feet 6 inches high; Bords: 8 yards wide x 5 feet 6 inches high; Cut-throughs: 5 yards wide; Pillars: 44 yard by 44 yard or 44 yard by 33 yard centres. Cliff falls & cracks occurred, and combustion of dumped coal reject continues to the present.

Photos: State Mine – cliff falls and surface fractures in the State Mine Airshaft No. 3/Lost City area – 17 July 2019

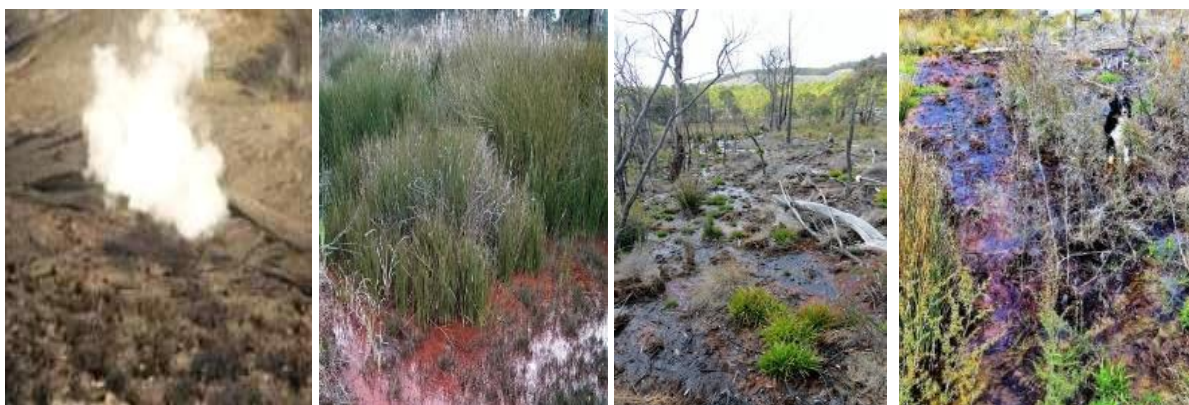
Photos: Coal combustion; Seepage and Acid Mine Drainage from Tyldsley Mine/Cullen Valley Mine – 12 September 2014

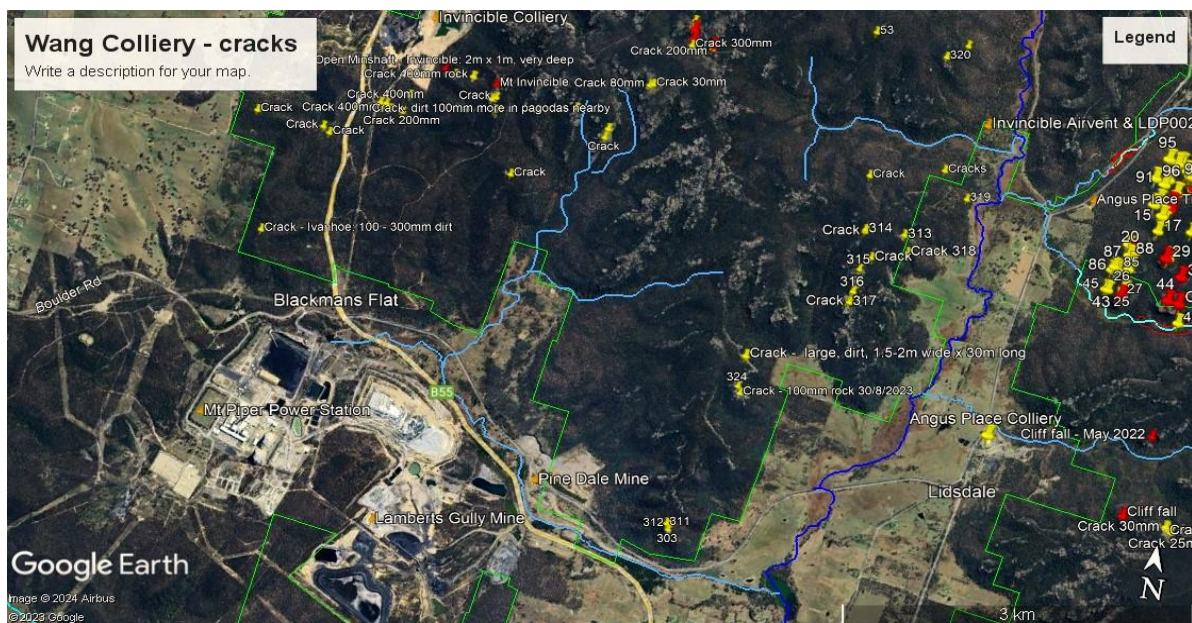
Figure: Mine subsidence cracks (Yellow Placemarks) recorded by LEG above bord & pillar workings of Wallerawang Colliery
