MINE SUBSIDENCE – HISTORY OF BORD & PILLAR MINING DAMAGE

Below are 80 examples at 20 Bord & Pillar mines refuting claims of ‘No evidence’ and ‘Negligible impacts’.

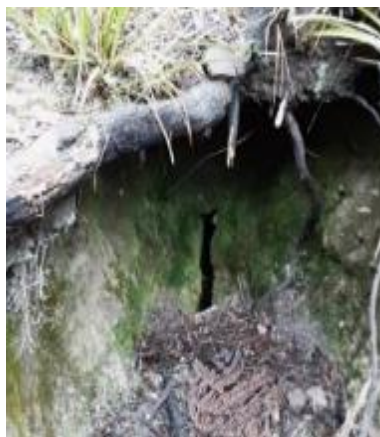
First recorded July 2010, last sighted April 2024. Large sinkhole 200m long x 10m wide x 2m deep with a 150-250mm wide subsidence crack at its eastern end. The crack runs east-west across a northerly flowing tributary of Bungleboori Creek. All surface water that once flowed down this creek now flows down that crack, and the creek and THPSS downstream are totally dry. Groundcover vegetation has not recovered in 14 years of observation, with many bare and denuded areas.

Photo2: Site 1 Crack in sinkhole June 2024

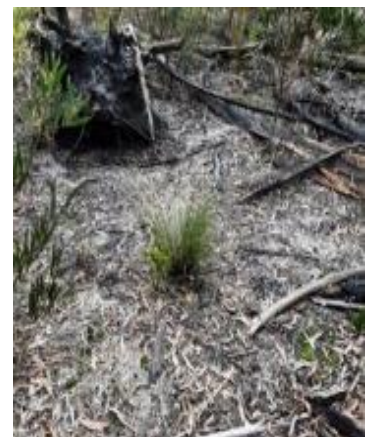
Photo3: Dry creek downstream 2024

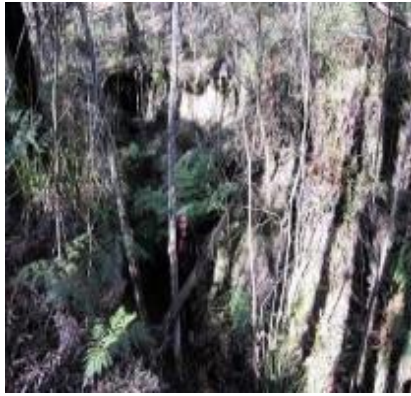
Photo 4: Site 1 Sinkhole – July 2010

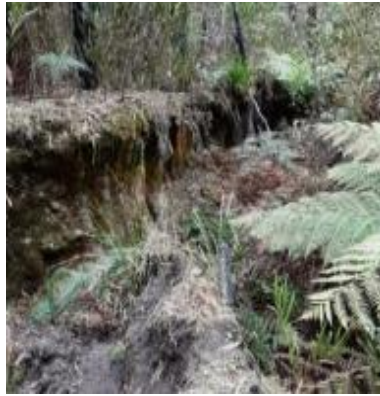
Photo 5: Site 1 Sinkhole – June 2024

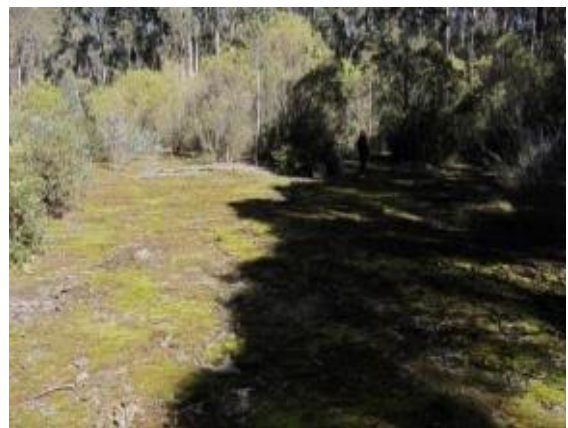
Photo 10: Site 3 Moss was the only vegetation in July 2010

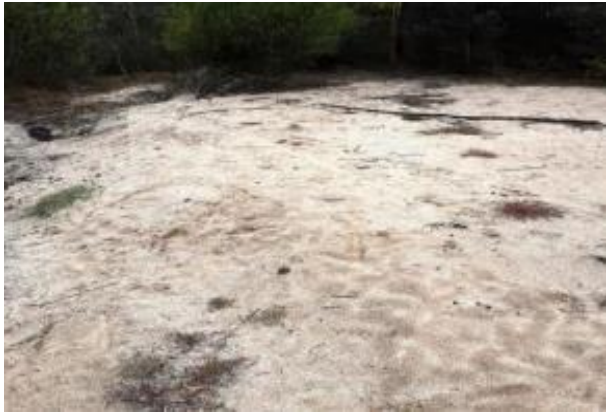
Photo 11: Site 3 All this unstable silt will end up in GBMWHA

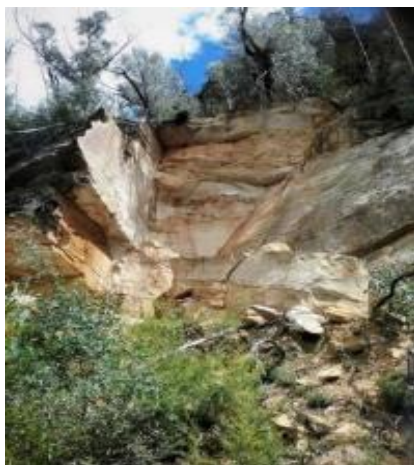
Recorded by LEG on 9 March 2018. The Clarence Colliery 2016 End of Year Report states that Panel 912 was approved on 7 June 2016 as part of the 900 Area Variation 3. The EPBC Referral for Clarence Colliery Panels 918-920 stated “the proposed action is not expected to result in any measurable direct or indirect impacts to geodiversity values (ie clifflines)”. Really??? (see also Site 18 & 19)

Photo 29: Cliff collapse - Panel 912

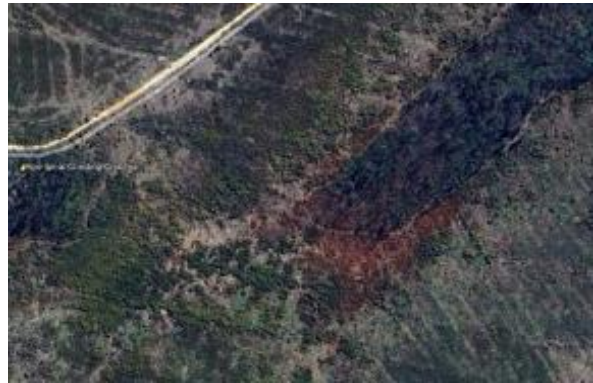
Google Earth imagery showed intact vegetation east of the Aboriginal grinding groove site off Waratah Ridge Road in July 2021, yet in August 2023 vegetation die-back was clearly visible. A dramatic drying event had occurred. The only disturbances in this area between 2021 and 2023 were Mustard Gas removal (didn't occur near this swamp) and mining of Clarence Colliery Panel 906 or possibly headworks for Panels 908 & 910. Groundwater levels may have been lowered to facilitate mining.

Photo 30: Site 10 Google Earth Imagery July 2021

Photo 31: Site 10 Google Earth Imagery August 2023

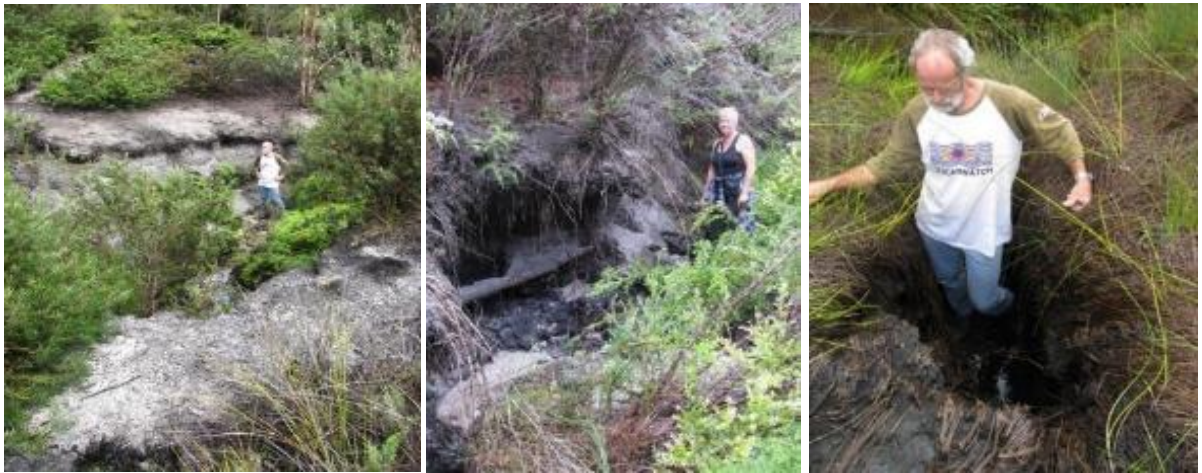
Farmers Creek South Swamp was drained by Clarence Colliery Panel 707 in 2012 and subsequently severely damaged by the State Mine Fire in October 2013. Previous damage had occurred due to the Clarence Water Transfer Scheme (CWTS) discharge point (33.456013, 150.222956).

Photos 37, 38, 39: Site 12 – Erosion, channelization, slumping downstream of Clarence Transfer discharge – 31 January 2010

The Sydney Catchment Audit 2010 included Recommendation 9: *Lithgow City Council & Centennial Coal should ensure that water transfers from the Clarence Water Transfer Scheme are piped around, rather than flow through, Farmers Creek Swamp.* The Federal Government provided \$4 million in funding.

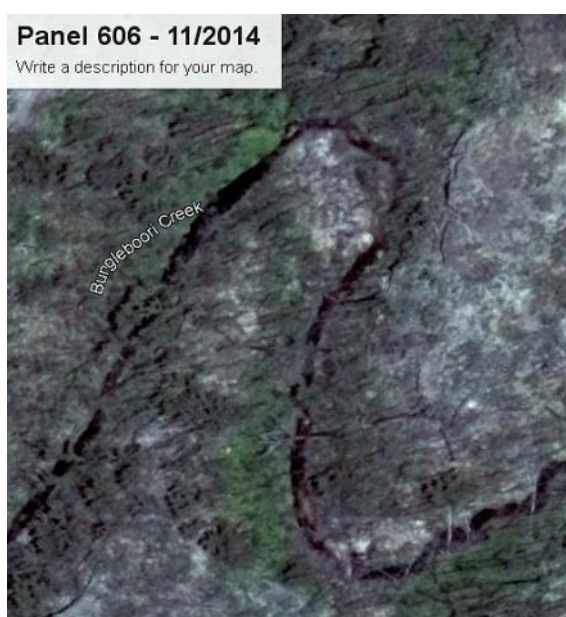
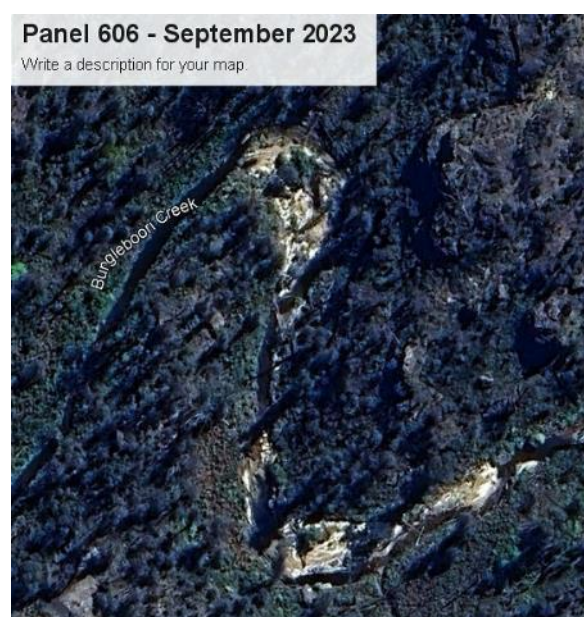
GoogleEarth imagery in November 2014 (after the October 2013 State Mine Fire) shows the stream path of Bungleboori Creek at the southern end of Clarence Colliery Panel 606 as being intact. In September 2024 (after December 2019 Gospers Mountain Fire) it was significantly disturbed. On inspection it appears that Bungleboori Creek has changed course in a more easterly & southerly direction. LEG believes this is not fire-related. Undermining of Bungleboori Creek by Panel 606 has likely resulted in subsidence altering the slope of the land surface and tilting of the creekbed.

Photo43: Google Earth Imagery 11/2014

Photo 44: Google Earth Imagery 09/2024

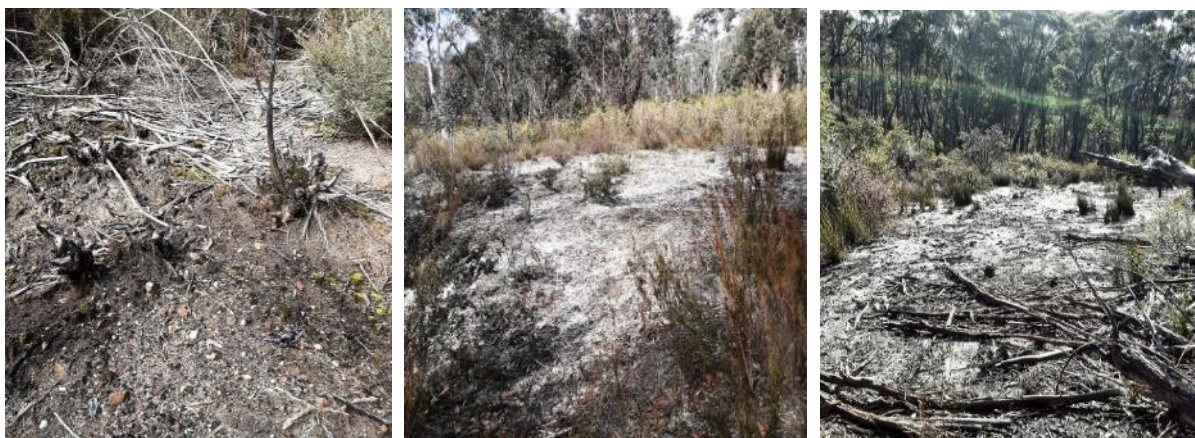
Several dead hanging swamps occur in this area, the creekline is dry and desiccated, and an arm of Bungleboori Creek downstream is totally dry. Whilst inspecting this site LEG recorded the threatened species *Pultenaea glabra* (EPBC Act - Vulnerable; NSW BCA - Vulnerable), not previously reported by Centennial as occurring in the Clarence Colliery Mine Lease. This raises serious questions about the adequacy of Centennials recording/reporting of Threatened Species at risk to its mining operations.

Photo 56-58: Site 15 Dead Hanging swamps, dry and desiccated creekline, dry creekbed downstream

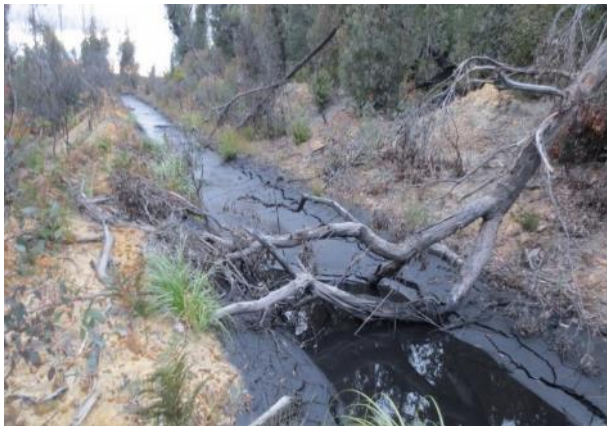
On 2 July 2015 part of the eastern wall of Reject Emplacement Area (REA) 3 failed, resulting in the release of coarse reject and 2,330 tonnes of coal fines into the Wollangambe River & GBMWHA. The Land & Environment Court convicted Clarence Colliery P/L of two offences and imposed financial penalties totalling \$1,050,000 plus \$106,010 in investigation and legal costs - the single largest fine following prosecution by the EPA.

Photo 62-69: Clarence Colliery Reject Emplacement Area ("REA") 3 – collapsed on 2 July 2015

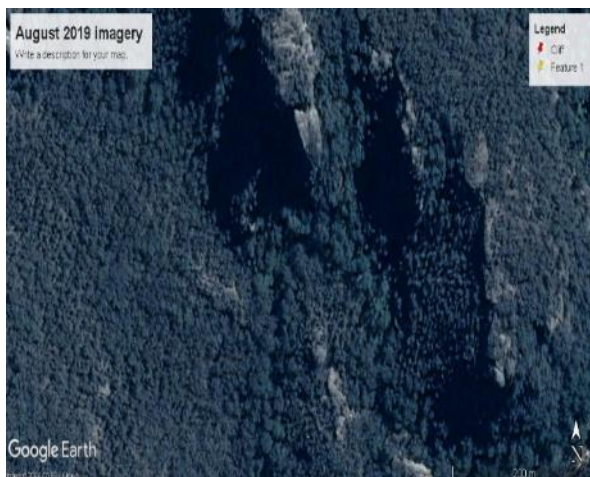
The cliff fall below occurred in the GBMWH A about 1km east of Clarence Colliery Panels 611A & B between 2019 and 2023. The cliff was about 60m high, and fallen rubble extends some 200m into Bungleboori Creek which appears to have been dammed-up. Far-field effects are entirely possible.

Photo 70: GoogleEarth imagery - August 2019

Photo 71: GoogleEarth imagery - September 2023

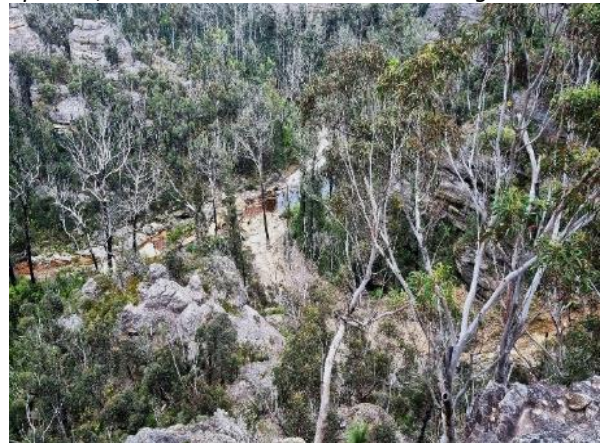
Photo 73-74: Cliff fall in GBMWH east of Clarence Colliery Panels 611A & 611B – 19 August 2024

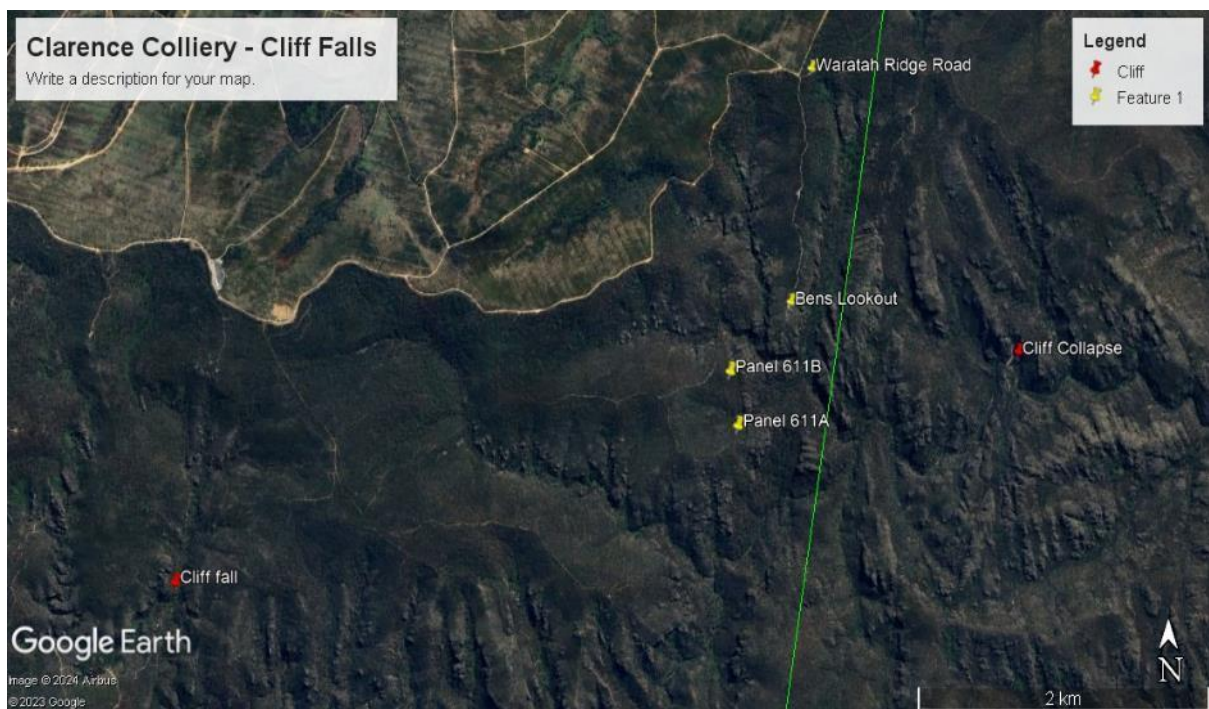
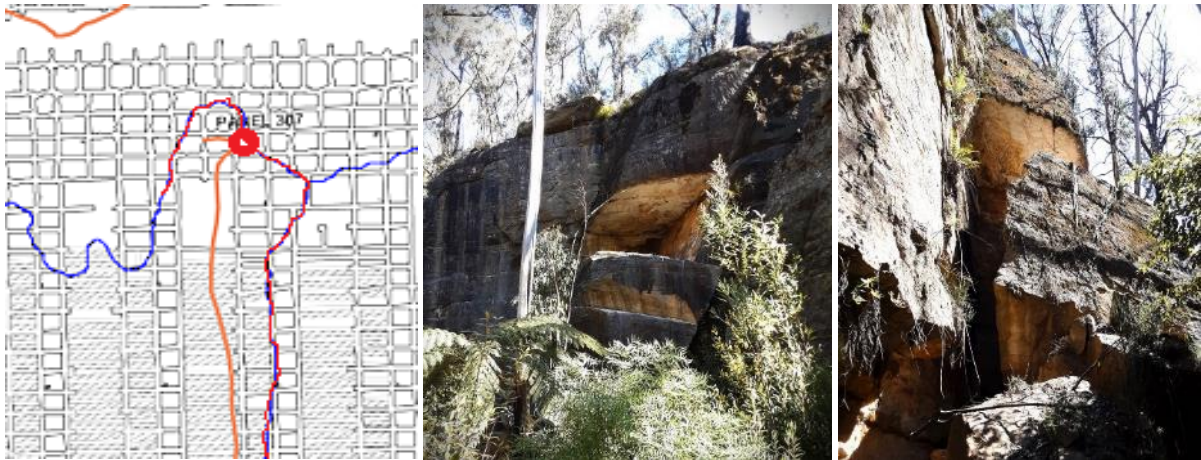
3.19 Site 19: Rock Fall – Panel 307 (-33.430213, 150.260434)

Recorded 4 September 2024. Appears to be a relatively recent rock fall. The creek (a tributary of Bungleboori Creek) in this vicinity has also dried up, both upstream and downstream.

Figure 4: Rock fall (red dot), dry creek

Photo 74 & 75: Site 19 Panel 307 – Rock fall and dry creek

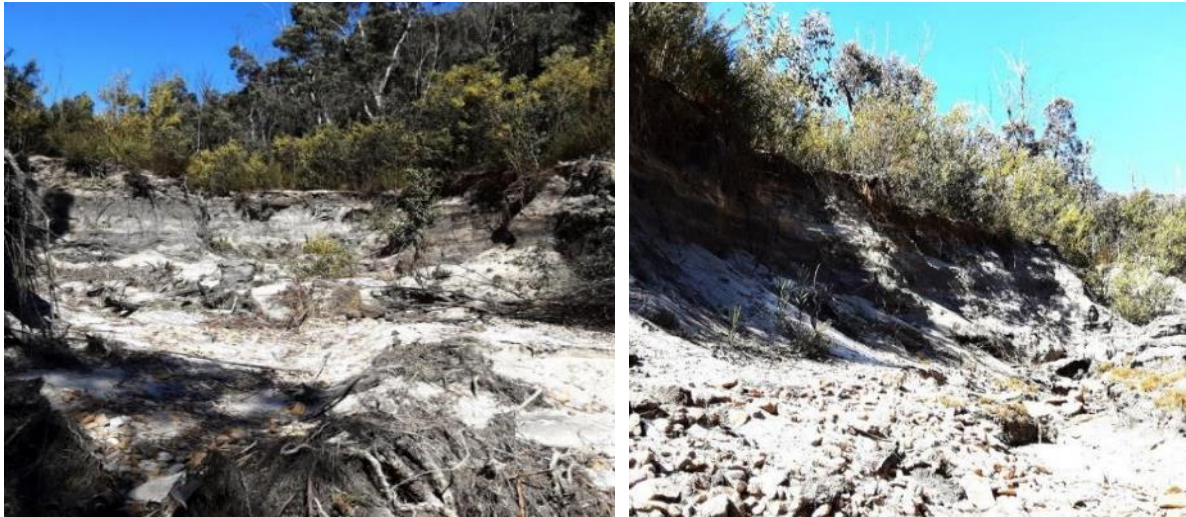
This is the most severe channelisation and erosion LEG has seen on Newnes Plateau. The most recent damage is clearly visible on Google Earth, extending for 200m and up to 20m wide x 4m deep. It corresponds almost exactly to where Panel 314 passed underneath this creek. Remnant *Olearia quercifolia* and other swamp species suggest THPSS or Hanging Swamps once occurred pre-mining.

Photo 78, 79: Clarence Colliery Panel 314 – relatively recent severe channelisation, erosion, slumping, dry creek

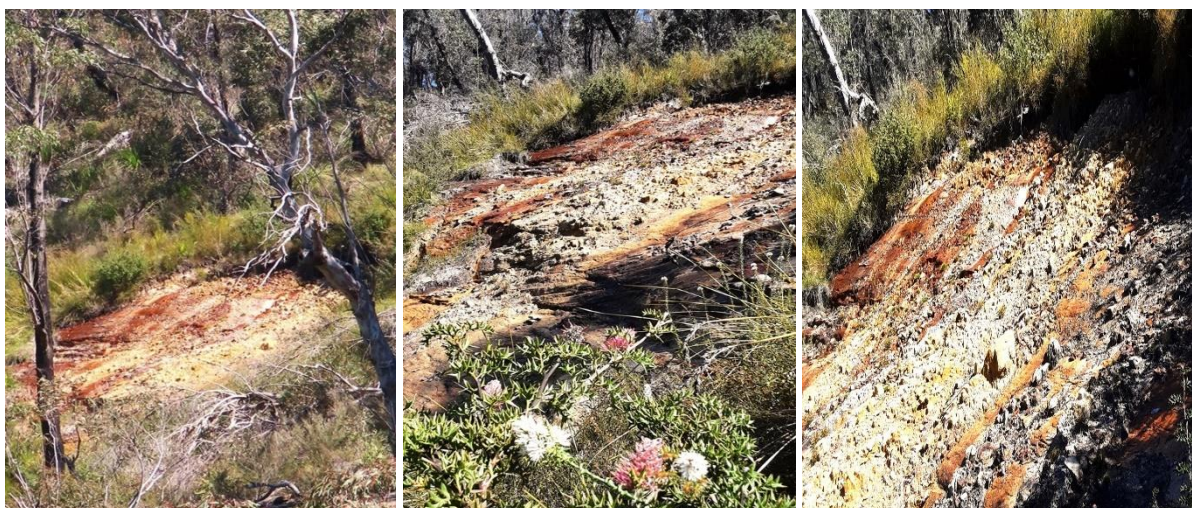
This small Hanging Swamp collapse above the Wollangambe River on the GBMWA boundary is fairly recent, and based on historic Google Earth imagery occurred sometime between July 2021 and September 2023. Whilst perhaps not mining related, it is only 400m east of Clarence Colliery REA3.

Photos 98-101: Site 25 Hanging Swamp collapse above Wollangambe River on GBMWA boundary

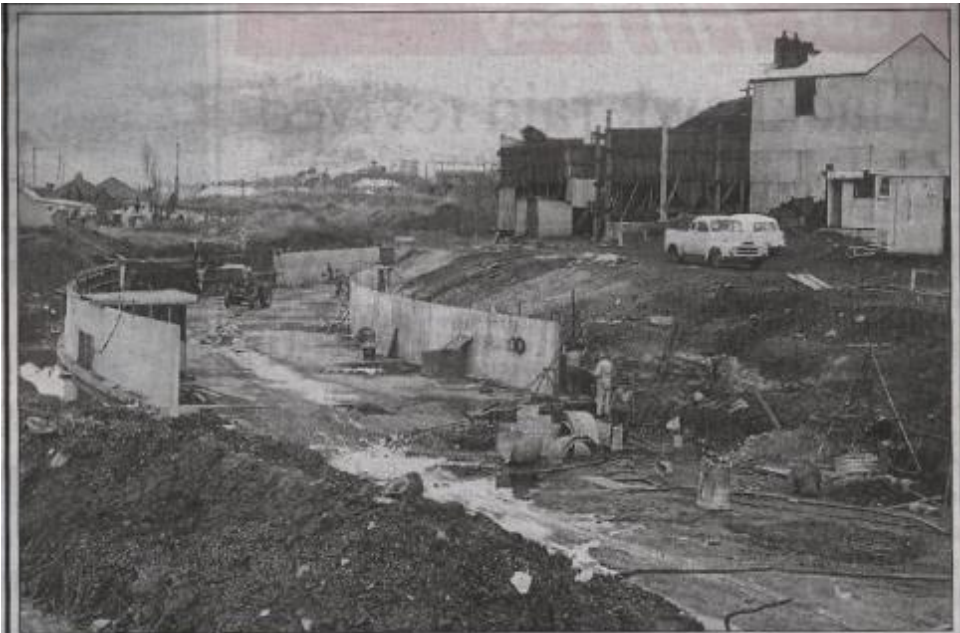
4.5 The 1964 floods saw Farmers Creek break into old Cobar Park Mine, flooding and closing the State Mine. The creek downstream dried up, and concrete lining had to be installed along 2.7km of Farmers Creek, which was therefore no longer a natural waterway. "Negligible impacts"???

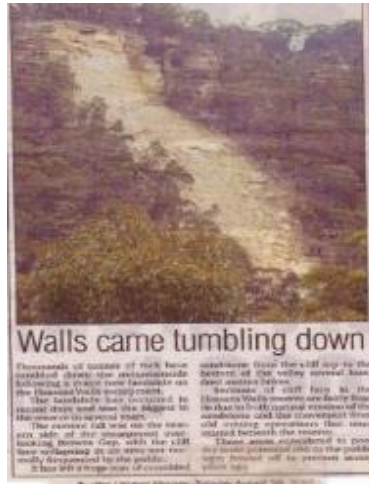
Photo 2: Lithgow Mercury 28/7/2007

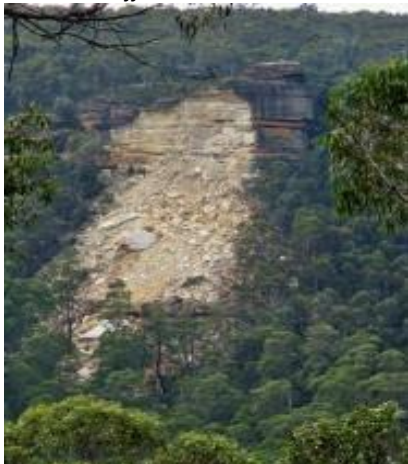
Photo 4: Hassans Walls – March 2015

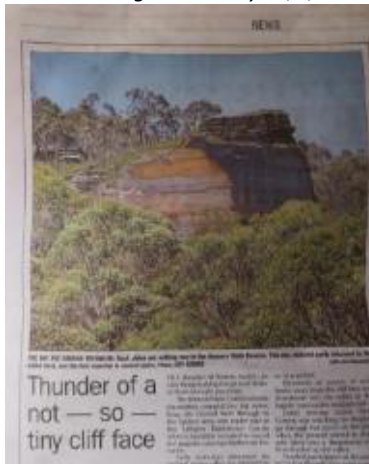
Photo 5: Lithgow Mercury 10/3/2015

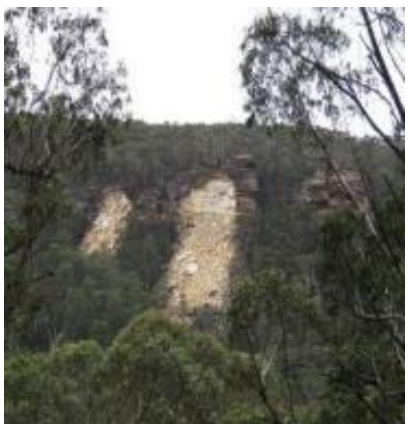
Photo 7: Hassans Walls – 20 June 2015

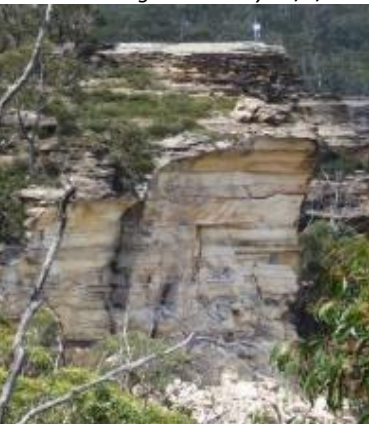
Photo 8: Hassans Walls – 20 June 2015

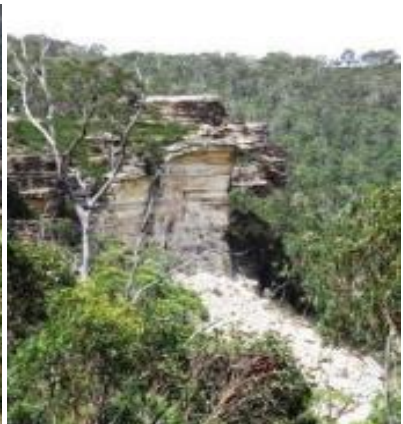
Photo 9: Hassans Walls 20 June 2015

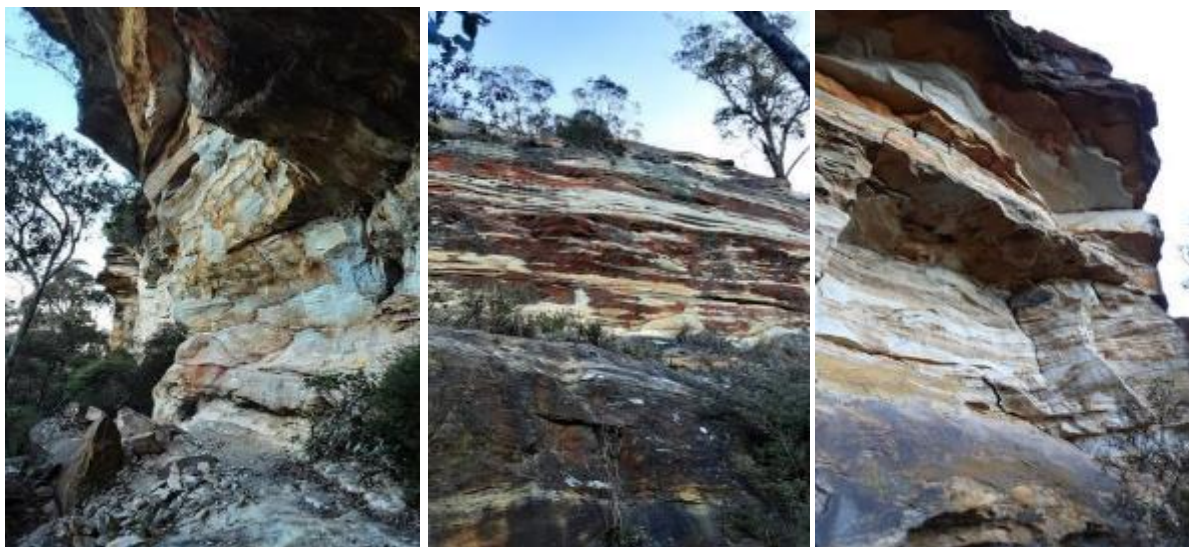
Photo 10, 11, 12: Hassans Walls cliff falls - Undercliff Track – photos taken 1 July 2023

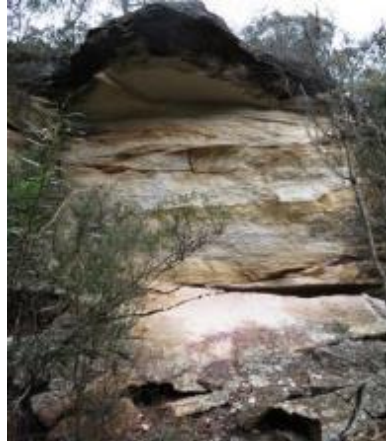
Photo: Cliff fall Invincible 9 August 2009

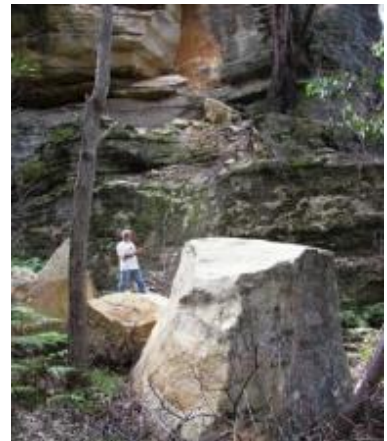
Photo: Cliff fall Invincible 9 August 2009

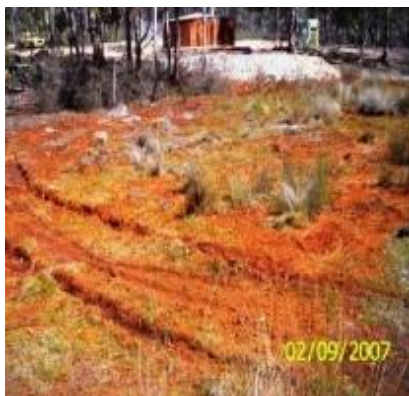
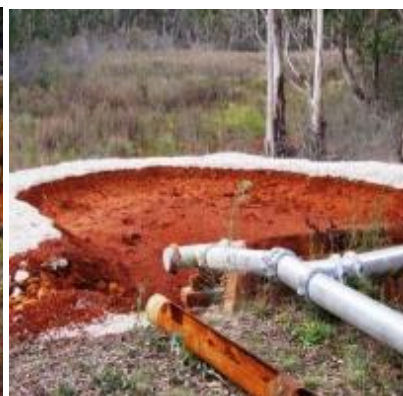
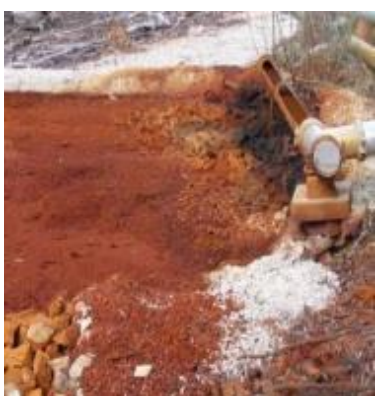
Photos: Invincible Colliery LDP01 discharge into Coks River – EC 1710uS/cm, pH 6.5, DO 0%, Anoxic odour - 2 September 2007

Invincible Colliery held two licenced discharge points into the Coxs River - LDP01 & LDP02. In June 2007, while conducting regular water quality monitoring under the SCA Streamwatch program, LEG observed LDP01 flowing strongly with an anoxic odour, extremely low Dissolved Oxygen levels, and the Coxs River downstream had turned a rusty-red colour. LEG advised the Sydney Catchment Authority (SCA), who conducted the sampling below on 28 June & 18 July 2007 –

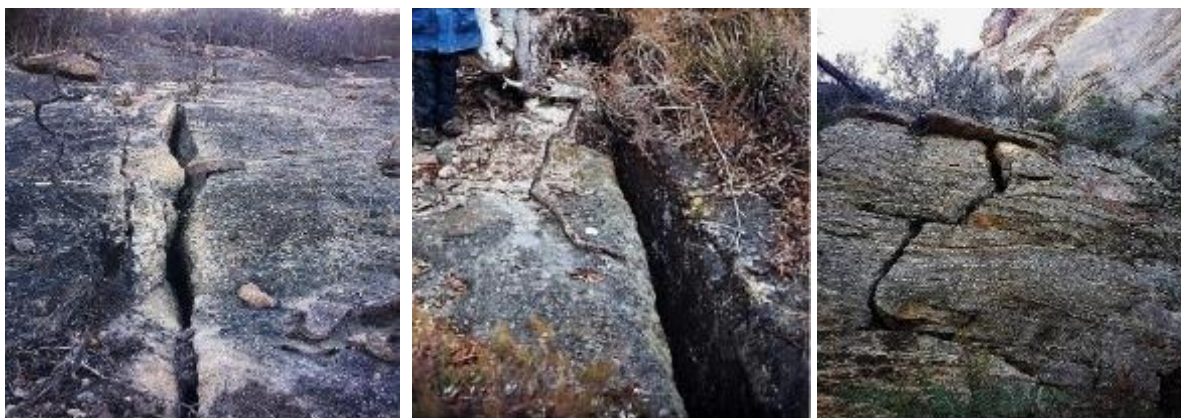
Photos: State Mine – cliff falls and surface fractures in the State Mine Airshaft No. 3/Lost City area – 17 July 2019

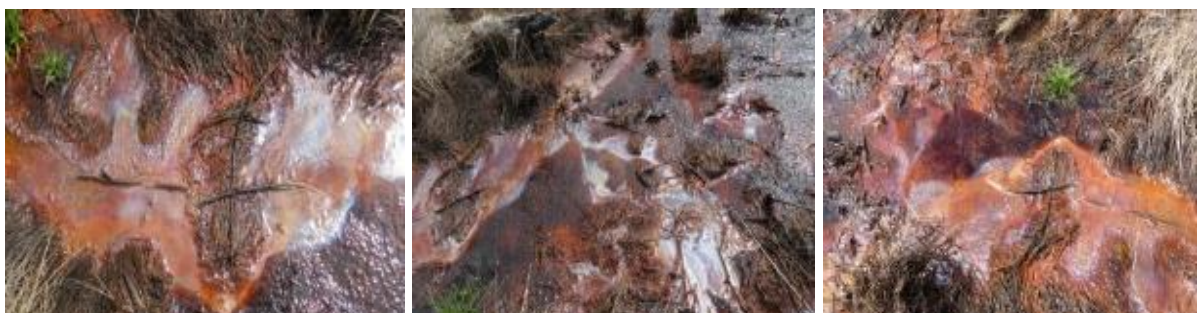
At both sites LEG recorded a salinity of 1600uS/cm (natural background levels are 30uS/cm), pH level of 4 (very acidic), and low Dissolved Oxygen level of 3.0 mg/L (healthy local streams are around 8 mg/L.)

Photos: Seepage from Tyldesley Mine/Cullen Valley Mine - Acid Mine Drain age/Saline Drainage – 12 September 2014
